INTRODUCTION

This summary will cover the technical aspects of both legs of the ATT Pacific cable survey (RC2610 and RC2611) which departed Honolulu on 27 August and ended in Hong Kong on 16 October with a brief stop in Guam (27 - 29 September.)

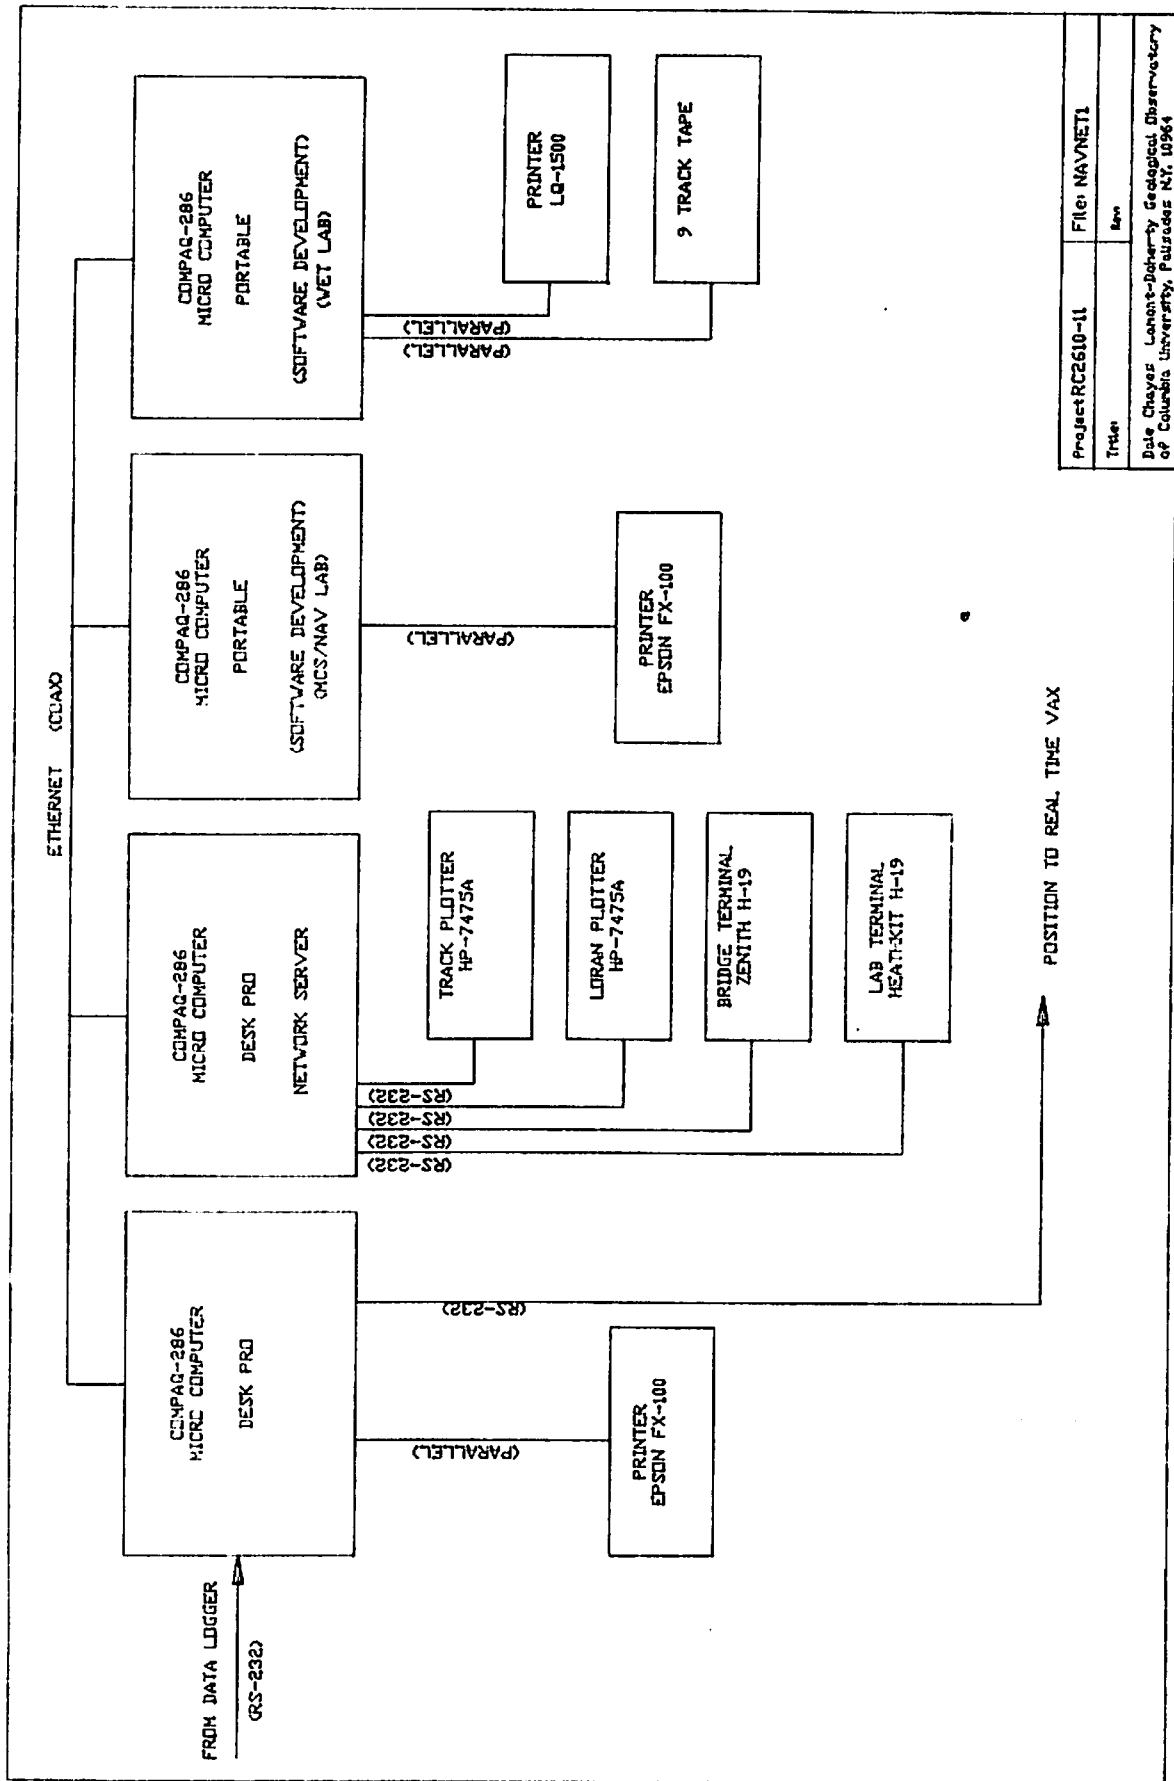
Project	RC2610-11	File	NAVNET1
Title		Rev	
Date Chayes: Lamont-Doherty Geological Observatory of Columbia University, Palisades NY, 10964

A network of Compaq-286 microcomputers were installed in Honolulu for the purpose of improving the real time navigation capability on the Conrad for the ATT survey. Of the four computers installed, two are used for real time tasks and the other two are used for software development. These computers are interconnected via an Ethernet Local Area Network (LAN) which allows the sharing of data files among cooperating programs.

The present system takes condensed navigation sensor data from the Data Logger and produces the following outputs:

- 1) Display of sensor input for the Lab and the Bridge
- 2) Sends position from the sensor of choice to SeaBeam
- 3) Displays detailed output from the Internav Loran C
- 4) Plots ships position from GPS, Loran-C, and Transit sat
- 5) Plots Loran-C signal Strength and ranges
- 6) Prints sensor input
