KN201 leg 05 16N Sentry Dive Summaries

WHOI ABE/Sentry Group

March 27, 2014

This document summarizes data from the AUV Sentry dives at 16N 46W. This report provides dive narratives and shows basic vehicle performance, sensor performance, and shows representative maps of chemical data. This report does not attempt to fully describe the scientific results or conclusions.

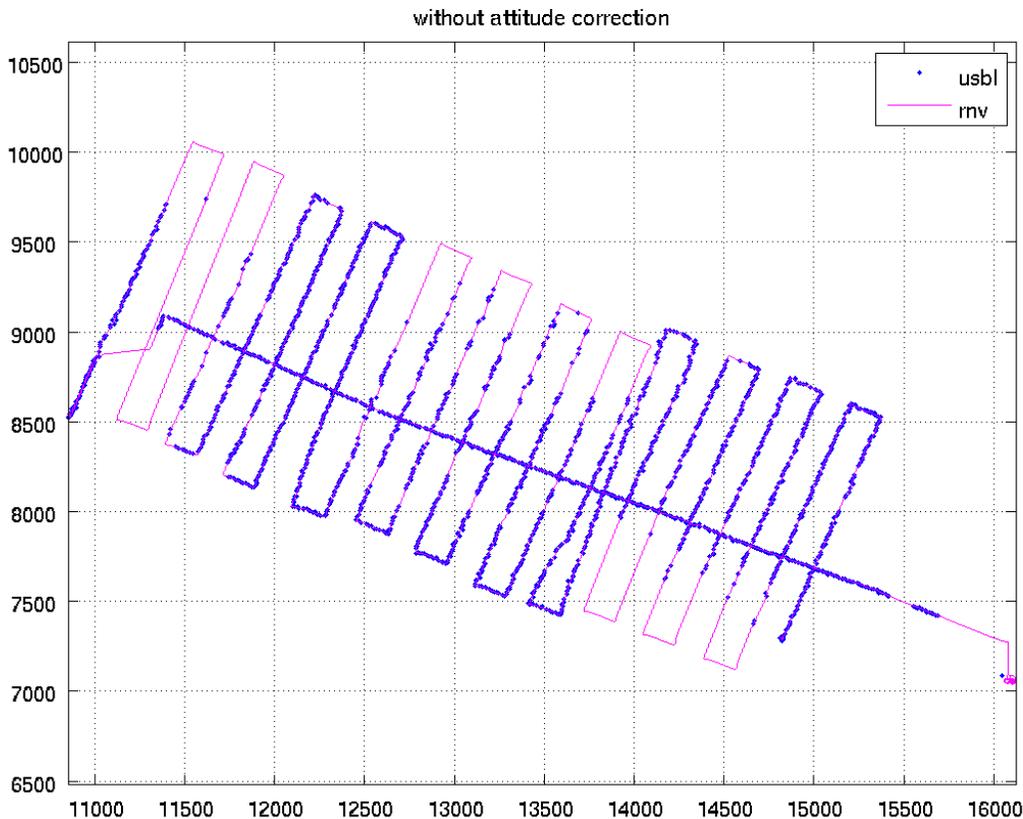
2. post-processing compensation for poor USBL calibration (casius). When the USBL is poorly calibrated, the vehicle appears to move in unexpected ways as the vessel moves or turns. Using the DVL/INS track from the vehicle, we were able to extract attitude offsets that resulted in USBL fixes that were far more consistent as the (see figures xx and xx). Without this capability, we would have had to redo the casius calibration or we would have had poor usbl for the entire cruise.

Figure 1: This plot shows the real-time USBL track and the blended USBL/INS/DVL track. The shifts in the USBL data correspond to vessel movement and do not correspond to the straight, uniform lines reported by the DVL/INS. With a high-quality casius calibration or better yet, an integrated INS/USBL head, this would not be a problem. While we certainly should improve our casius calibration skills (Yoerger and Kurras), we will face these problems in the future

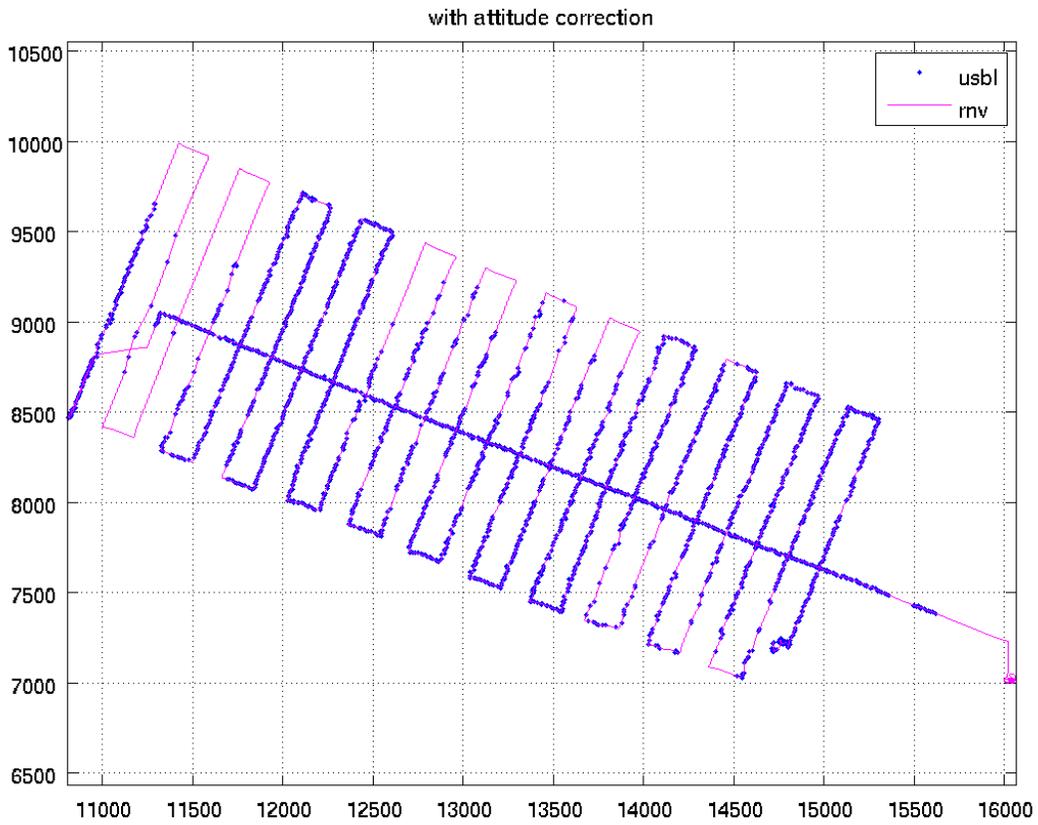
Figure 2: This plot shows the USBL track and the blended USBL/INS/DVL track after correcting the USBL data with the DVL/INS track. The correction, applied in post-processing, restores the complimentary nature of the USBL and the DVL/INS track. We applied this correction to all USBL navigation for all dives

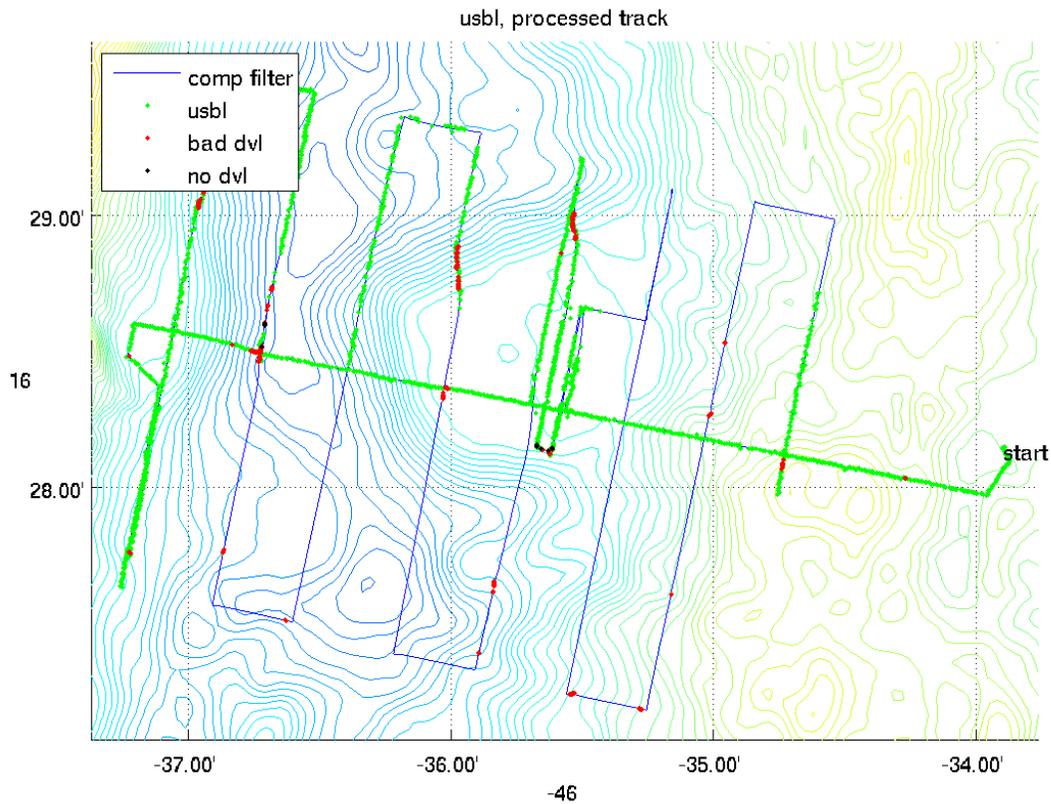
Figure 9: This plot shows the vehicle fixes and processed tracklines for dive 179. The green markers indicate the USBL fixes after transformation and flyer-rejection. The blue trace indicates the final track with blends the USBL fixes and the DVL/INS track. The black markers indicate missing DVL readings and the red markers indicate where DVL readings were received but were judged bad based on high v velocity. On this dive, we see many bad dvl readings with the resulting “wobbles” where the vehicle drives upslope

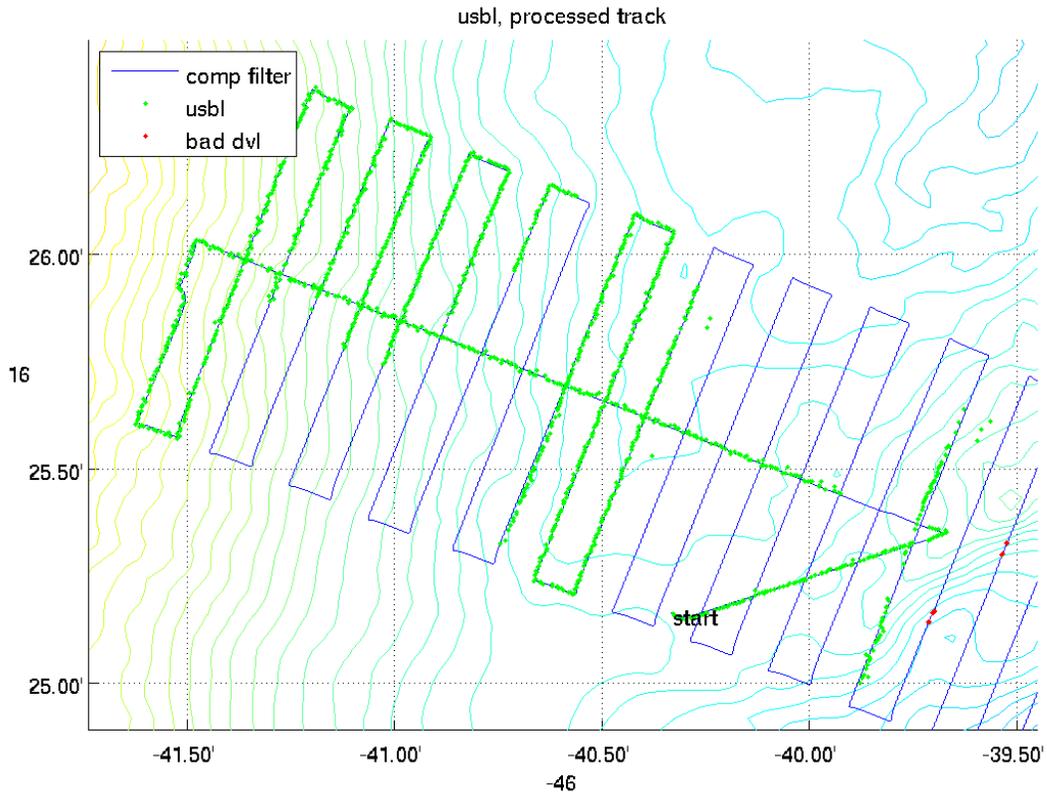
Figure 11: This plot shows the vehicle fixes and processed tracklines for dive 18. The green markers indicate the USBL fixes after transformation and flyer-rejection. The blue trace indicates the final track with blends the USBL fixes and the DVL/INS track. The black markers indicate missing DVL readings and the red markers indicate where DVL readings were received but were judged bad based on high v velocity. On this dive, we see many bad dvl readings with the resulting “wobbles” where the vehicle drives upslope

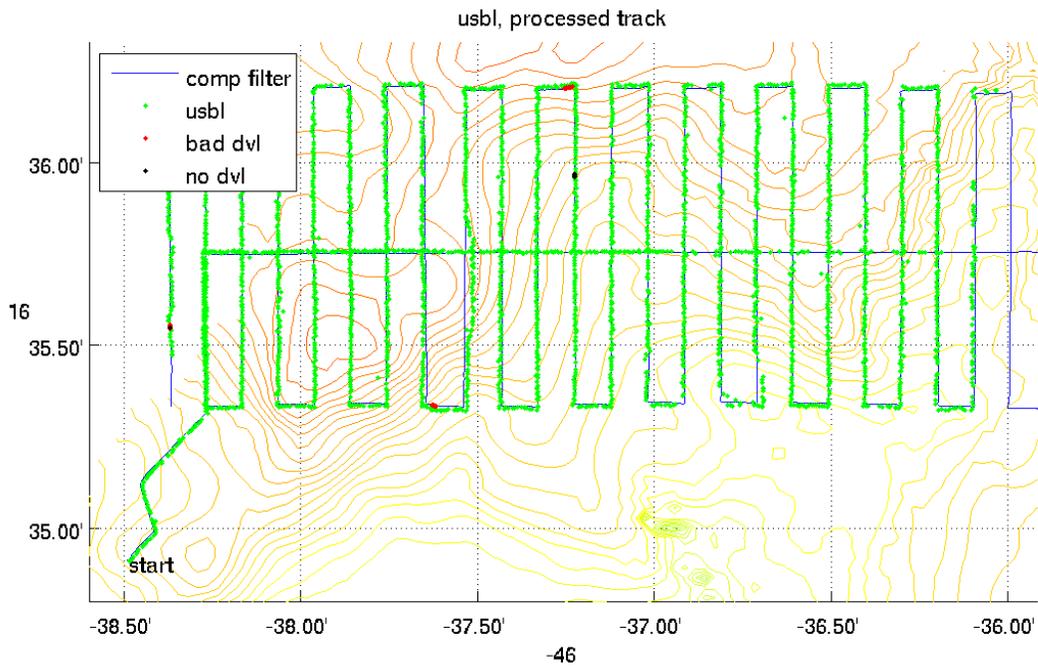
Figure 13: This plot shows the vehicle fixes and processed tracklines for dive 181. The green markers indicate the USBL fixes after transformation and flyer-rejection. The blue trace indicates the final track with blends the USBL fixes and the DVL/INS track. The black markers indicate missing DVL readings and the red markers indicate where DVL readings were received but were judged bad based on high v velocity. On this dive, we see many bad dvl readings with the resulting “wobbles” where the vehicle drives upslope

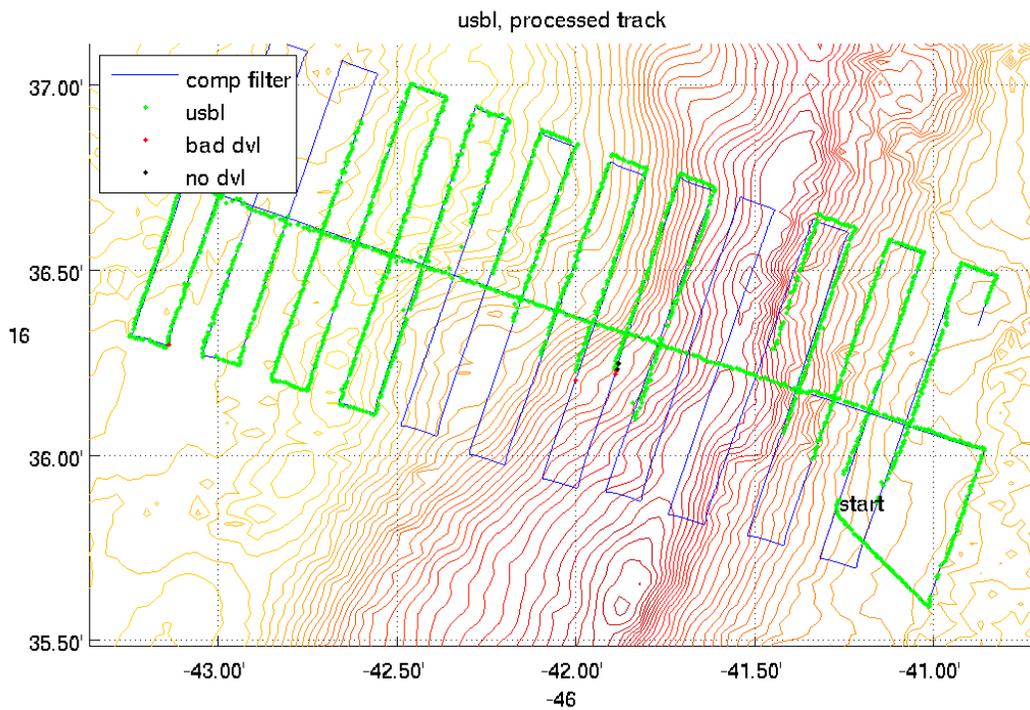
Figure 15: This plot shows the vehicle fixes and processed tracklines for dive 182. The green markers indicate the USBL fixes after transformation and flyer-rejection. The blue trace indicates the final track with blends the USBL fixes and the DVL/INS track. The black markers indicate missing DVL readings and the red markers indicate where DVL readings were received but were judged bad based on high v velocity. On this dive, we see many bad dvl readings with the resulting “wobbles” where the vehicle drives upslope

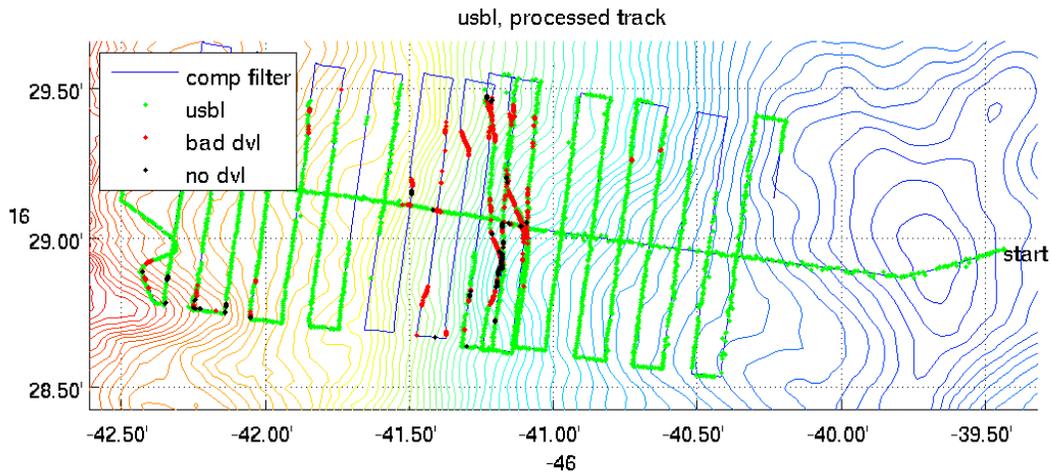
Figure 17: This plot shows the vehicle fixes and processed tracklines for dive 183. The green markers indicate the USBL fixes after transformation and flyer-rejection. The blue trace indicates the final track with blends the USBL fixes and the DVL/INS track. The black markers indicate missing DVL readings and the red markers indicate where DVL readings were received but were judged bad based on high v velocity. On this dive, we see many bad dvl readings with the resulting “wobbles” where the vehicle drives upslope

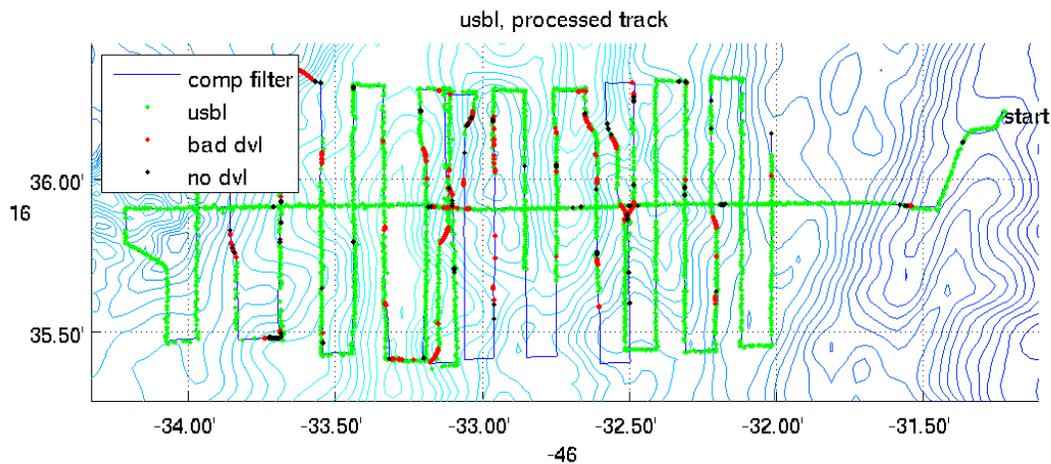
Sentry184 mapped an area at the latitude of Sentry181 and Sentry182 but did not connect to them. The terrain was rough and the navigation suffered significantly with numerous “wobbles” resulting in gaps and poor matches between swaths. Processing to improve the map is ongoing as of this writing (2013/06/17).

Figure 19: This plot shows the vehicle fixes and processed tracklines for dive 184. The green markers indicate the USBL fixes after transformation and flyer-rejection. The blue trace indicates the final track with blends the USBL fixes and the DVL/INS track. The black markers indicate missing DVL readings and the red markers indicate where DVL readings were received but were judged bad based on high v velocity. On this dive, we see many bad dvl readings with the resulting “wobbles” where the vehicle drives upslope

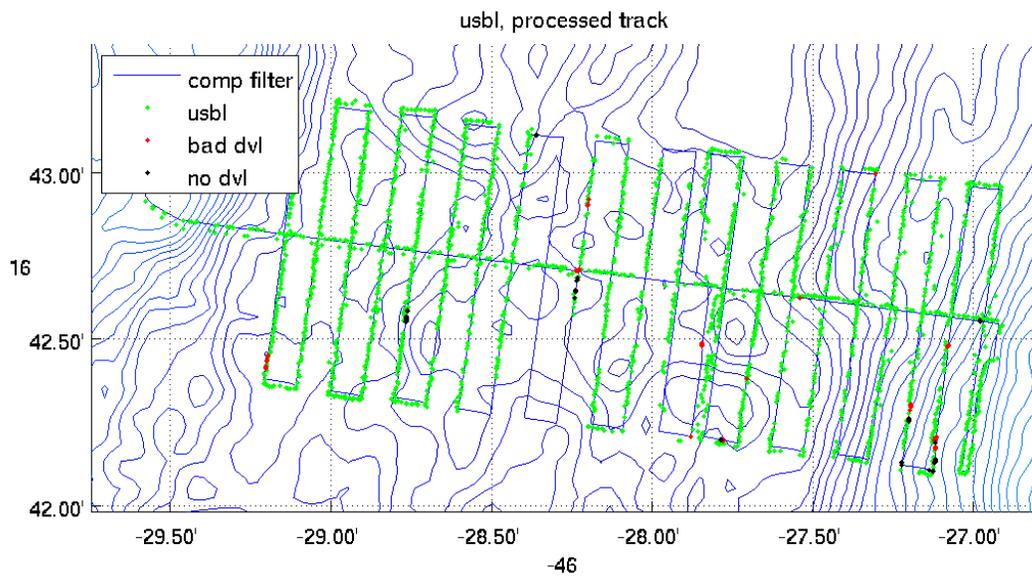
Sentry185 was the first, eastern-most block in the 16 44' area. It included a crossing line. The terrain was relatively benign and navigation was very good with minimal DVL problems except at the end of the last trackline where a significant “wobble” was noted.

Figure 21: This plot shows the vehicle fixes and processed tracklines for dive 185. The green markers indicate the USBL fixes after transformation and flyer-rejection. The blue trace indicates the final track with blends the USBL fixes and the DVL/INS track. The black markers indicate missing DVL readings and the red markers indicate where DVL readings were received but were judged bad based on high v velocity. The USBL coverage was consistent and the DVL problems were minimal. We noted on large DVL “wobble” at the end of the last trackline

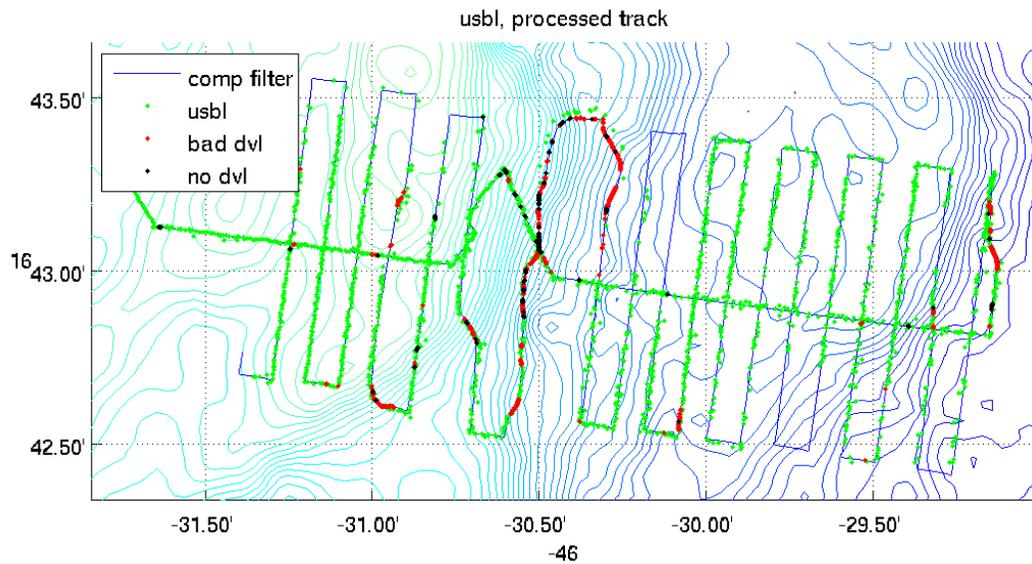
Sentry186 was the second block in the 16 44' area. It included a crossing line. The vehicle navigation experienced several shifts on the steep terrain, which included a scarp over 200m high. These shifts correspond to the identified problem DVL pings based on our v-velocity and missing fixes.

Figure 23: This plot shows the vehicle fixes and processed tracklines for dive 186. The green markers indicate the USBL fixes after transformation and flyer-rejection. The blue trace indicates the final track with blends the USBL fixes and the DVL/INS track. The black markers indicate missing DVL readings and the red markers indicate where DVL readings were received but were judged bad based on high v velocity. The dive plan included a crossing line, then several fill-in lines to the east to patch missing sections from the previous dive. The vehicle encountered many dvl “wobbles” on the steep terrain as indicated by the black and red markers. We had very sparse USBL coverage in the eastern main block, as the vessel was out of range for dredging.

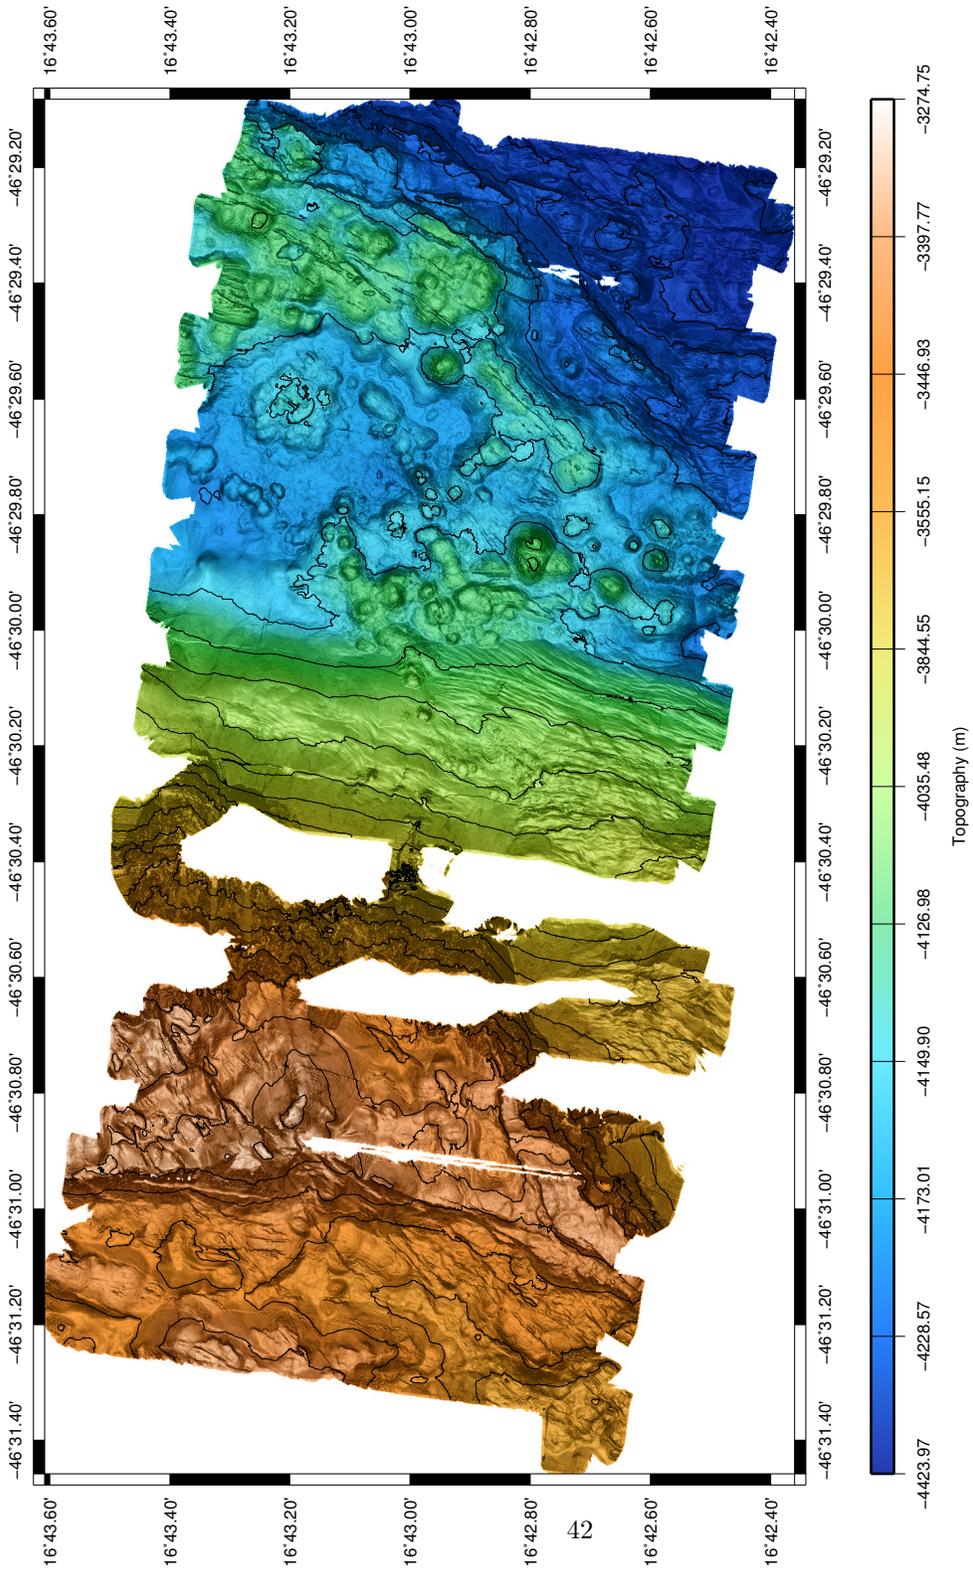
The main part of the map has good coverage and internal consistency with the exception of gaps caused by DVL errors. The bathymetry was processed using the standard method for this cruise with two passes of navigation adjustment.

Figure 24: Bathymetry for Sentry186. The DVL “wobbles” resulted in gaps on the steep terrain

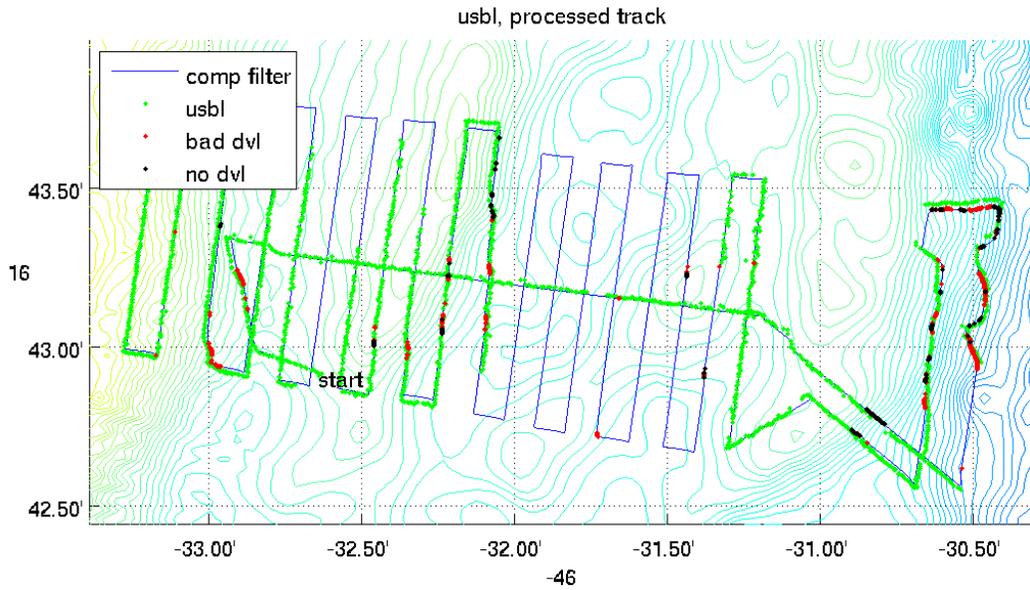
Figure 25: This plot shows the vehicle fixes and processed tracklines for dive 187. The green markers indicate the USBL fixes after transformation and flyer-rejection. The blue trace indicates the final track with blends the USBL fixes and the DVL/INS track. The black markers indicate missing DVL readings and the red markers indicate where DVL readings were received but were judged bad based on high v velocity. The dive plan included a crossing line, then several fill-in lines to the east to patch missing sections from the previous dive. The vehicle encountered many dvl “wobbles” on the steep terrain as indicated by the black and red markers. We had very sparse USBL coverage in the eastern main block, as the vessel was out of range for dredging.

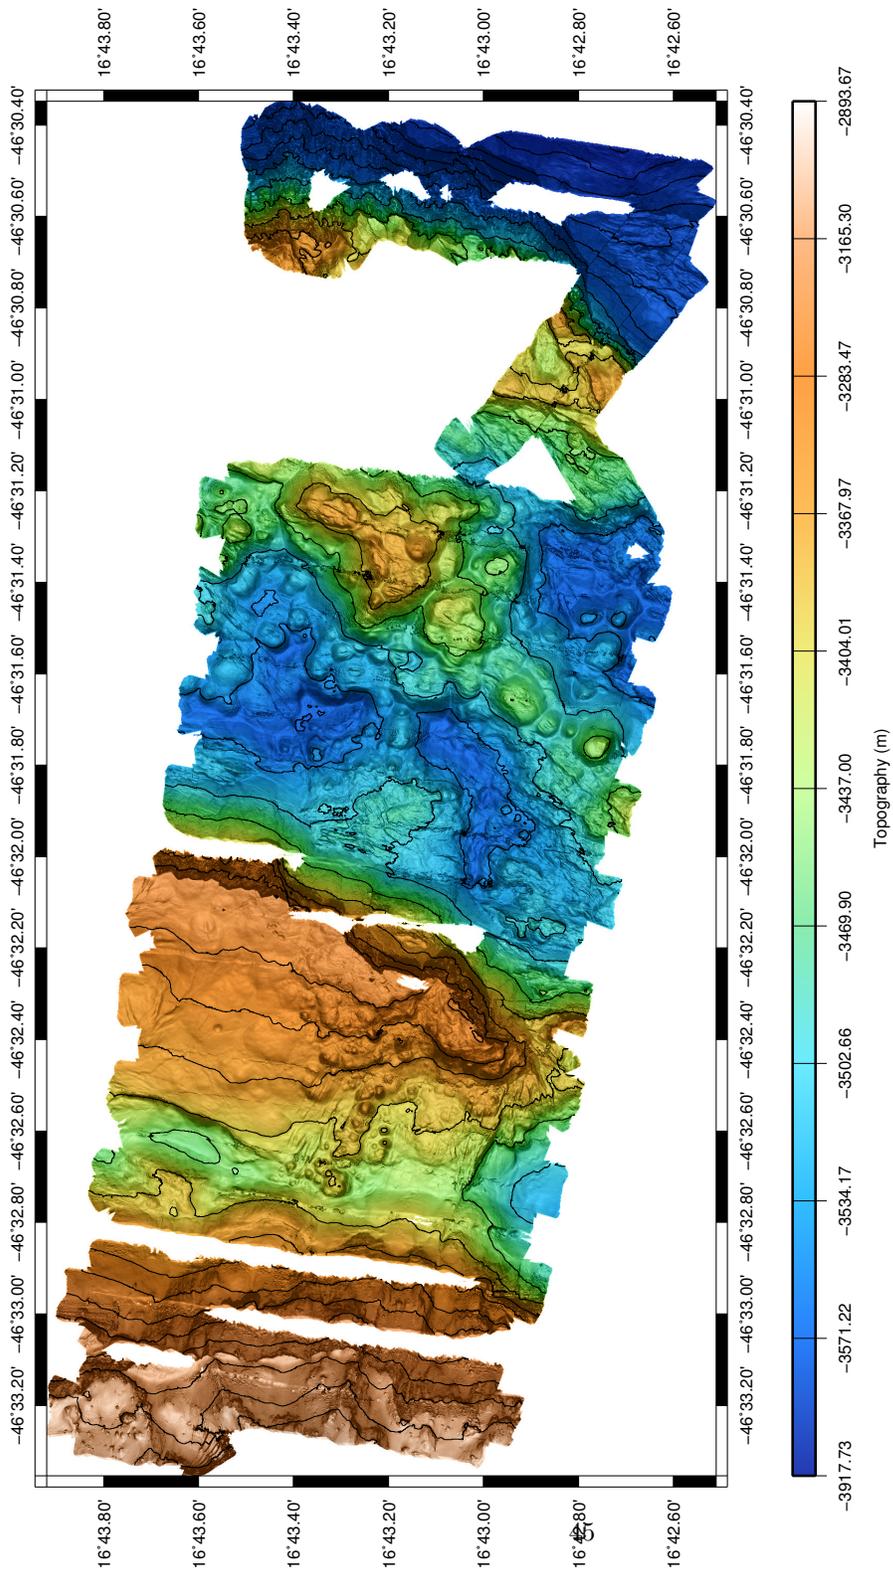
The main part of the map has good coverage and internal consistency with the exception of two gaps caused by DVL errors.

Figure 26: Bathymetry for Sentry187. The DVL “wobbles” resulted in gaps on the steep terrain

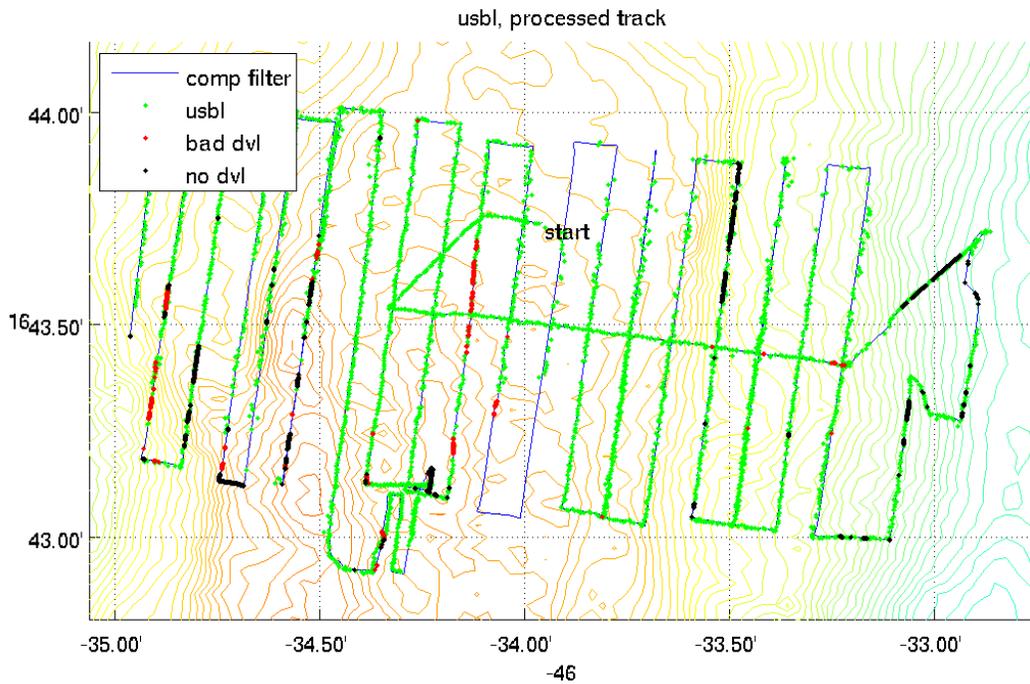
Figure 27: This plot shows the vehicle fixes and processed tracklines for dive 188. The green markers indicate the USBL fixes after transformation and flyer-rejection. The blue trace indicates the final track with blends the USBL fixes and the DVL/INS track. The black markers indicate missing DVL readings and the red markers indicate where DVL readings were received but were judged bad based on high v velocity.

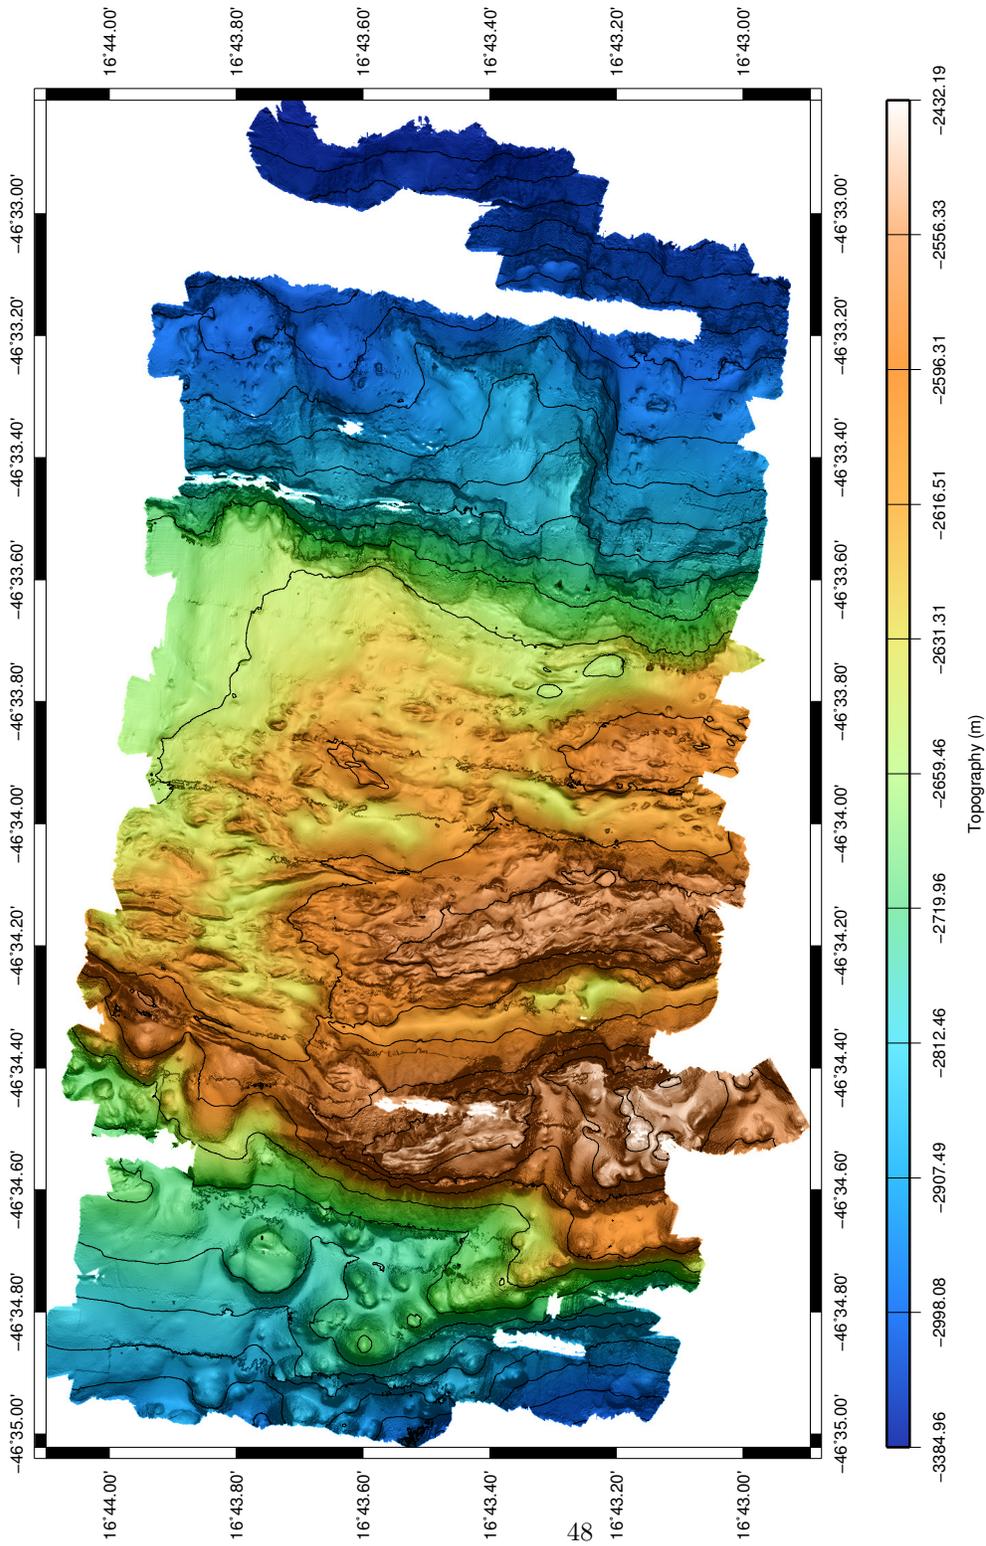
Figure 28: Bathymetry for Sentry188. The DVL “wobbles” were absent even on steep terrain. The gaps on the east side were intentional, the eastern-most lines were fill-in lines for gaps in Sentry187
