IG-24-4 23 Apr. 2356 to 23 May @ 0730

Planning IG 24-4

IG 24-4

Problem with DFS

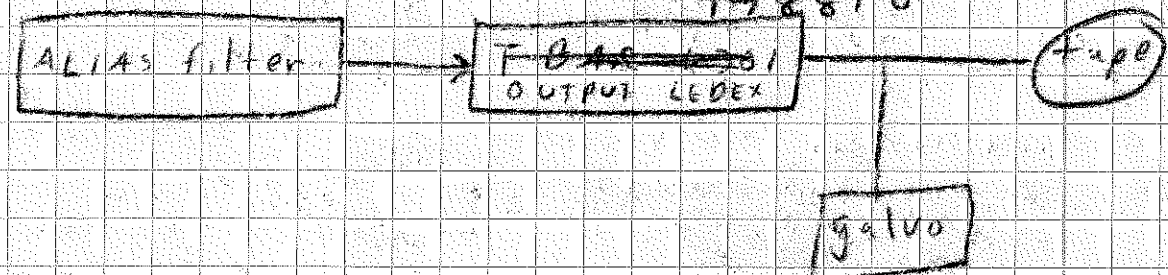
Symptom - RC/RP ^{monitor} records badly ^{monitor} when in record mode OK.

Cause - sticking of OUTPUT ^{LEDEX} ~~174550~~ ^{S310} ~~174550~~ ¹⁷⁴⁵⁵⁰ references TI drawing

Apparently if monitor records mode when normal record mode is OK then data is on tape OK. - for LEDEX is concerned RECORD mode monitors less OK.
