Cruise Report

R/V MARCUS G. LANGSETH

U.S. Law of the Sea Cruise to Map the Foot of the Slope of the Northeast U.S. Atlantic Continental Margin: Leg 8

**Cruise MGL15-12
July 30 – August 29, 2015
New York, NY to Woods Hole, MA**

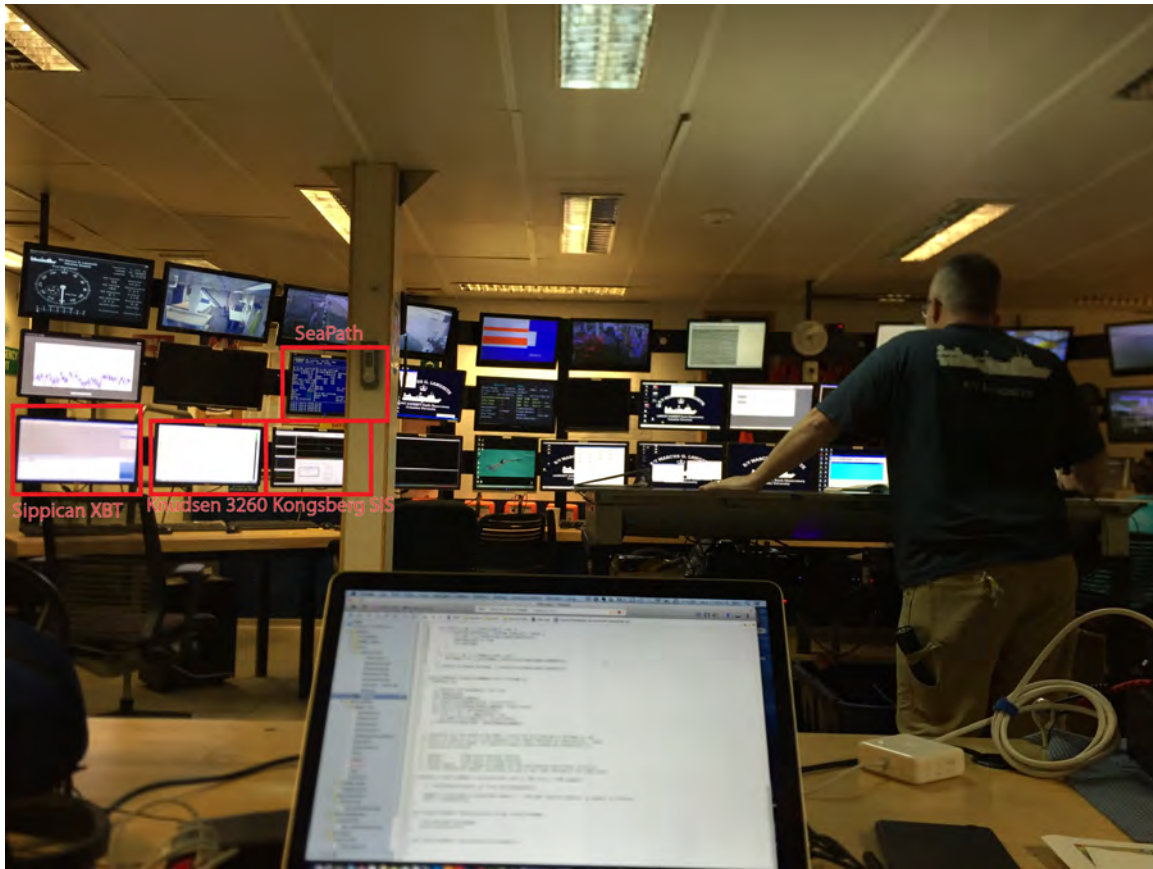
Figure 4: Placement of instrument displays in the main lab of the *Langseth* during the mapping mission.

Figure 4 shows the placement of the instrument displays in the main lab. A summary of serial numbers and software versions is provided in

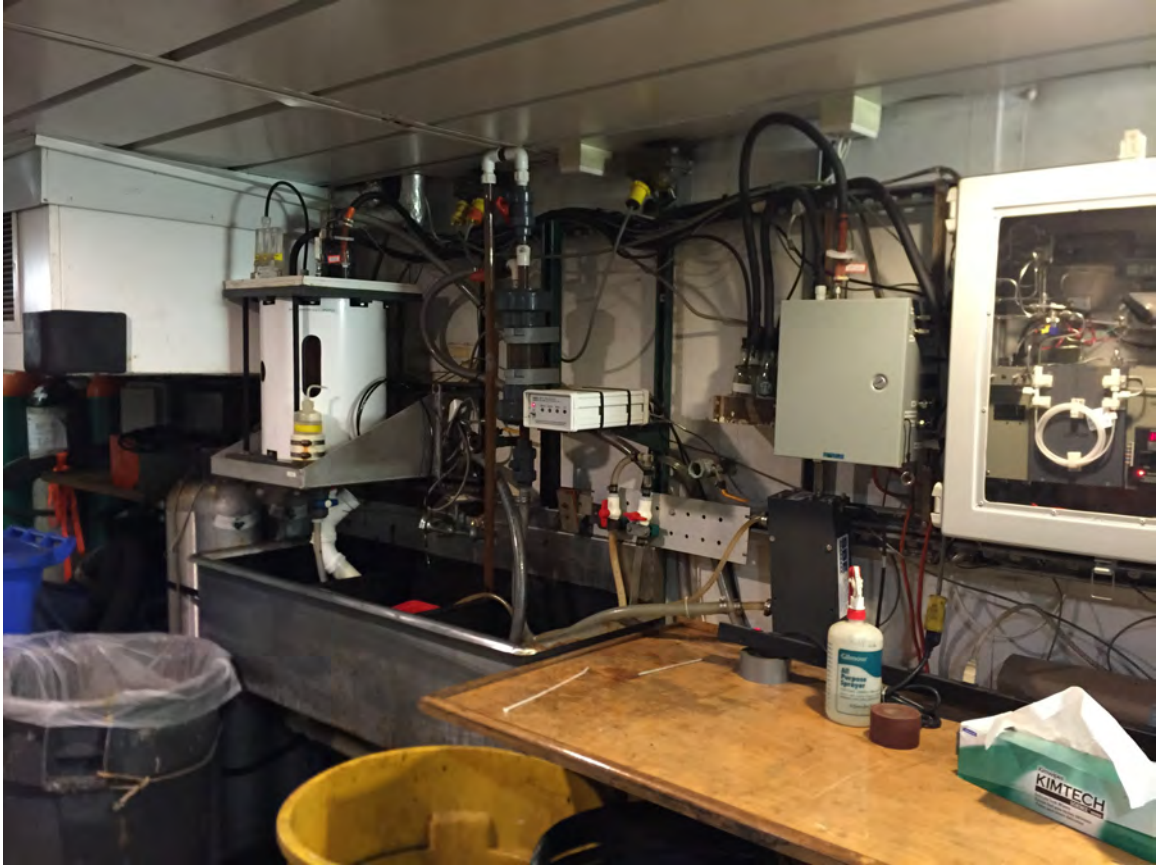
Figure 6: The main-deck wet lab of the R/V Langseth during MGL15-12. The de-bubbler for the TSG is the wall-mounted grey cylinder in the center of the image, with the white pCO₂ tank to the left, and the gas analyzer to the far right. The dark grey box plumbed into the sink is the TSG.

0100: Conducted a walk-through of the configuration of the TSG and Micro sv sensors with the LDEO technicians. The TSG is in the *Langseth's* main-deck wet lab space, [Figure 6](#), where sea water from an intake at the same level as the transducer, and approximately 1.5-3m forward on the hull, was led through approximately 30 m of piping to a de-bubbler, and then into the **TSG (Figure 7)**.

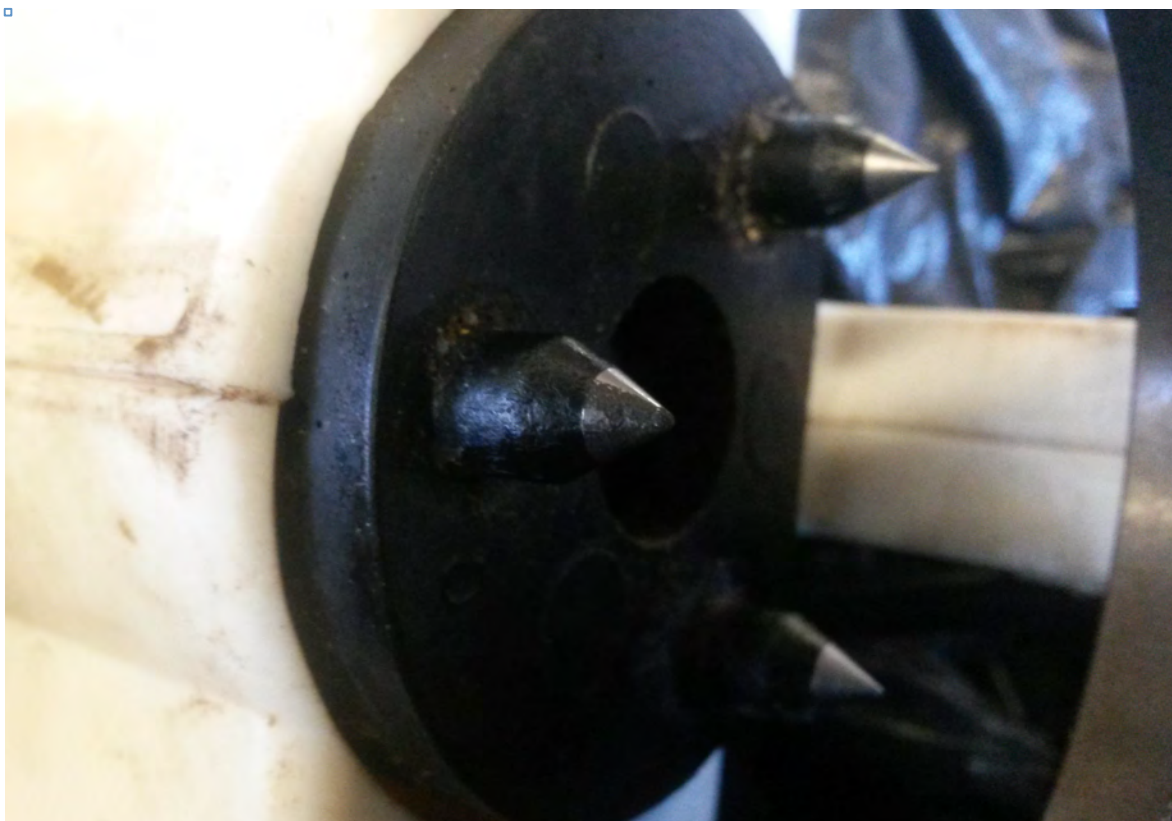
Figure 13: Detail of the XBT launcher with the corroded terminal connector (left). Intermittent contact with the pads in the XBTs caused failures in recognizing new probes, and in collecting data during operations. A new launcher was subsequently substituted.

Several failures to launch XBTS triggered an investigation into possible causes. A visual inspection of the XBT system components identified the presence of corrosion on one of three terminals of the launcher (Figure 13). A replacement launcher was substituted, and immediately resolved the problem.

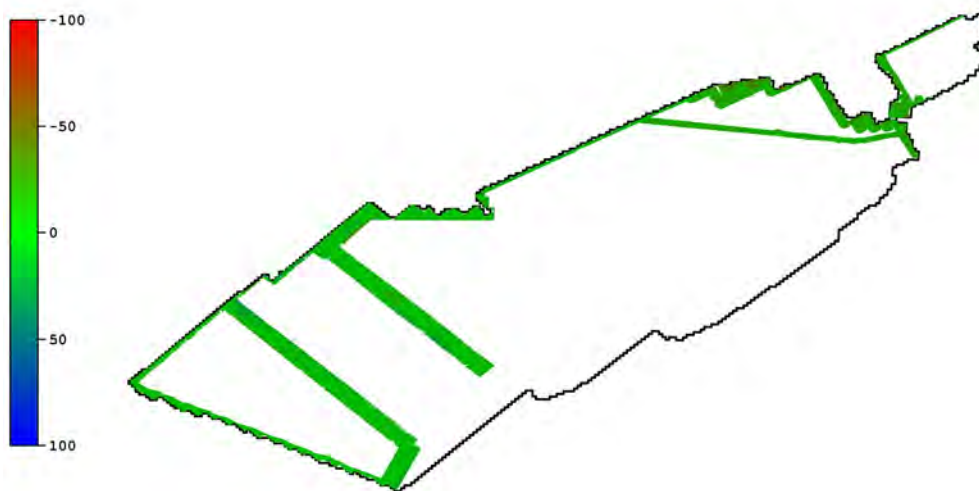
Figure 23: Surface differences between previous legs of the U.S. east coast mapping campaign, Okeanos Explorer EX13-03, and leg 8 (black outline). Differences range between -215m and 274m, with mean -0.8m and standard deviation 11.6m.
