# CRUISE REPORT

### U.S. Law of the Sea Cruise to Map the Western Flank of the Kingman Reef-Palmyra Atoll Section of the Line Islands, Equatorial Pacific Ocean

Cruise KM15-20  
November 20 – December 20, 2015  
Honolulu, HI to Honolulu, HI

December 20, 2015  
UNH-CCOM/JHC Technical Report 15-002

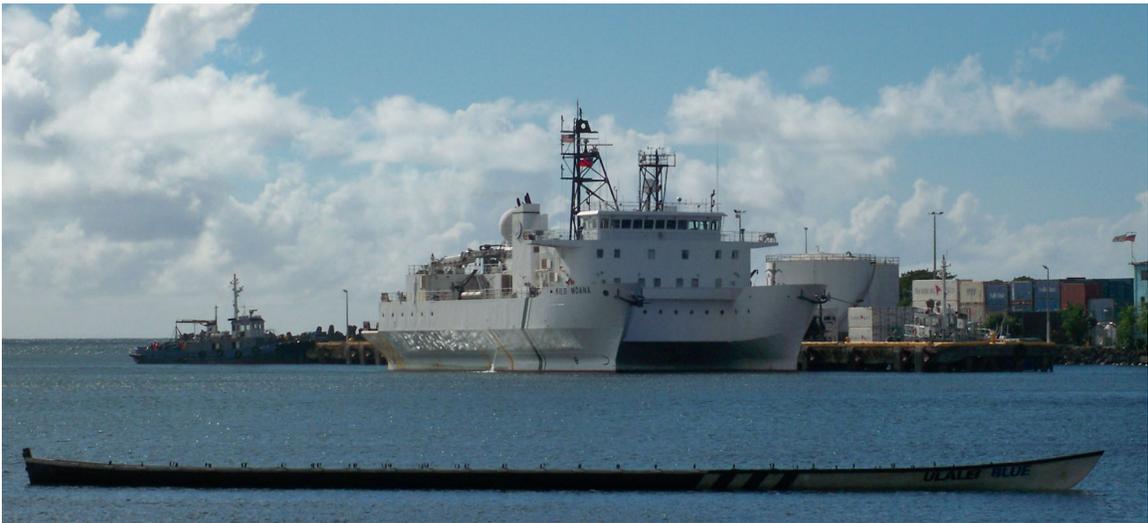
Figure 1.2: The R/V *Kilo Moana* in Apia, Western Samoa, in 2010. The *Kilo Moana* is a SWATH (Small Water Area Twin Hull) vessel owned by the U.S. Navy and operated by the University of Hawai'i.

This cruise supplements data from a prior cruise [2] to identify the morphology of the Foot of the Slope (FoS) around the northern end of the Line Islands chain, Figure 1.1. The cruise consisted of primary bathymetric mapping in water depths of approximately 5000 m using the R/V *Kilo Moana* (Figure 1.2), operated by the University of Hawai‘i. The primary mapping sonar was a Kongsberg EM122 multi-beam echosounder (bathymetry and acoustic backscatter), with a Knudsen Engineering 3260 chirp sub-bottom profiler, and a Bell Aerospace BGM-3 marine gravimeter. Motion measurement was provided by an ApplAnix POS/MV 320 GPS-aided inertial motion unit, while sound speed profile measurements were conducted using Sippican expendable bathythermograph (XBT) and expendable conductivity, temperature and depth (XCTD) probes. Details of the systems used can be found in Section 2. Scientific personnel for the cruise were provided by CCOM-JHC, Memorial University, University of Southern Mississippi, NOAA National Center for Environmental Information, and GEOMAR (Helmholtz-Zentrum für Ozeanforschung Kiel), and the marine technician group provided by University of Hawai‘i. The personnel list can be found in Section 6.

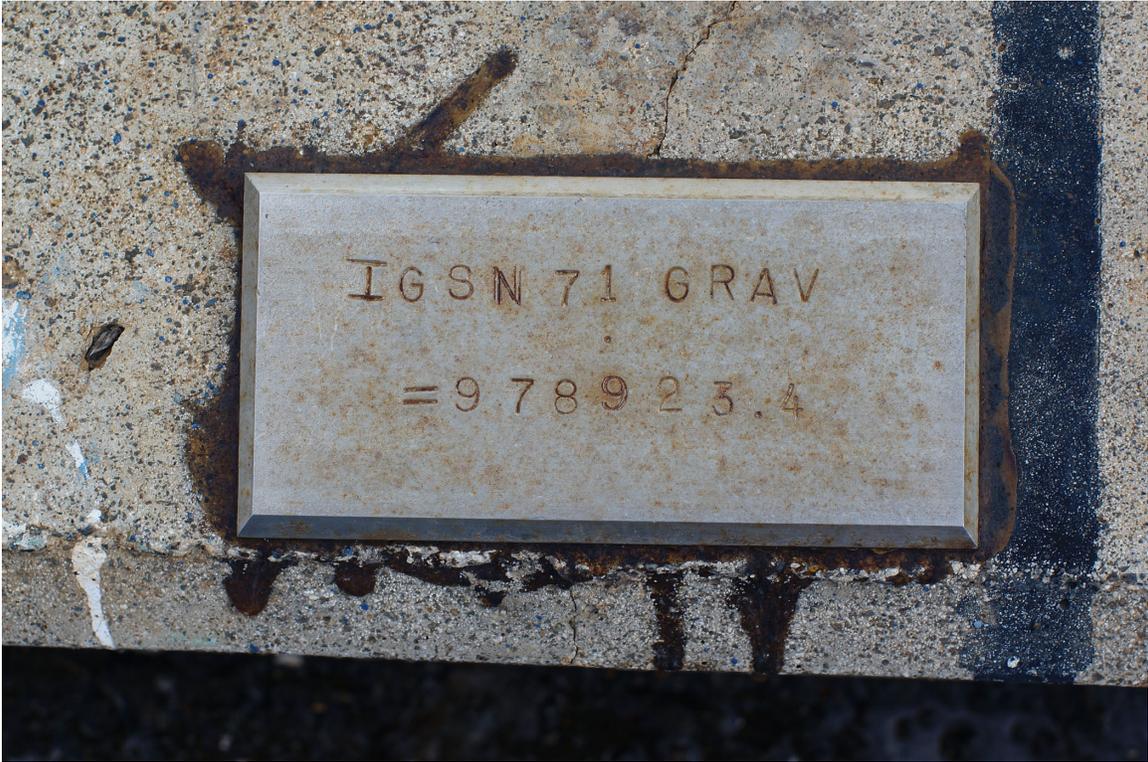
Figure D.7: Gravity station monument plaque corresponding to the station description in Figure D.6.
