MGLN06MV ABE Dive Engineering Summaries

August 30, 2006

1 Introduction

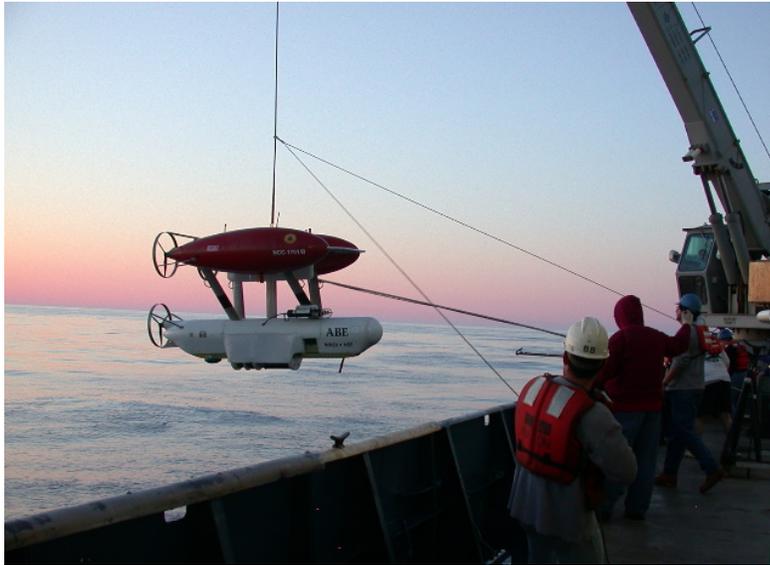
Figure 1: This photo shows ABE being recovered after a plume mapping dive

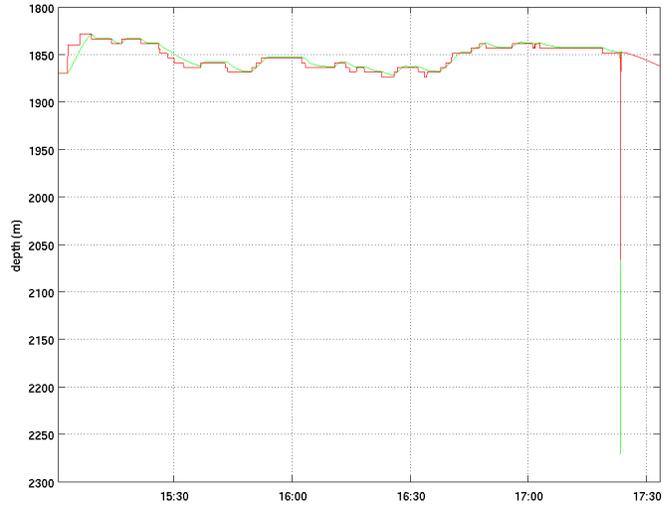
Figure 64: ABE193: This plot shows the bad depth reading that triggered the abort. ABE is programmed to abort if it reads depth below a preset maximum. In this case, the bad reading triggered the abort.

ABE193 was intended to enlarge the survey of NE Pual. The dive was shortened substantially by a technical problem. ABE's depth sensor reported that ABE's depth suddenly increased by about 500 meters. This bad value made it through the filters designed to reject noisy values and triggered an abort condition for exceeding the maximum allowed depth (set several hundred meters below the deepest possible depth in the survey area). The measured depth trace, including the bad reading, is shown in figure 64. In 192 dives and several thousand hours of bottom time, we had never seen this problem.

ABE's routine that processes the depth information includes a 5-point median filter to reject erroneous, inconsistent readings. In this case, the filter was not effective since the interface module can return identical readings on consecutive interrogations if the input data from the depth sensor has not updated. Repeated readings for which the actual sensor data has not been refreshed are not flagged (this is one of our oldest interface modules and this deficiency has been corrected in newer versions). If the reading in the interface module was bad, it could have been read out 3 times (we tested for this) before it changed, which would have allowed it to be accepted by the filter. While an unlikely event, this is the best explanation
