SENTRY OPERATIONS REPORT FOR THE
RR2106 RESING CRUISE

WHOI Sentry Operations Group

R/V Revelle — Sep 18th through Nov 6th

Publication Date: November 2, 2021

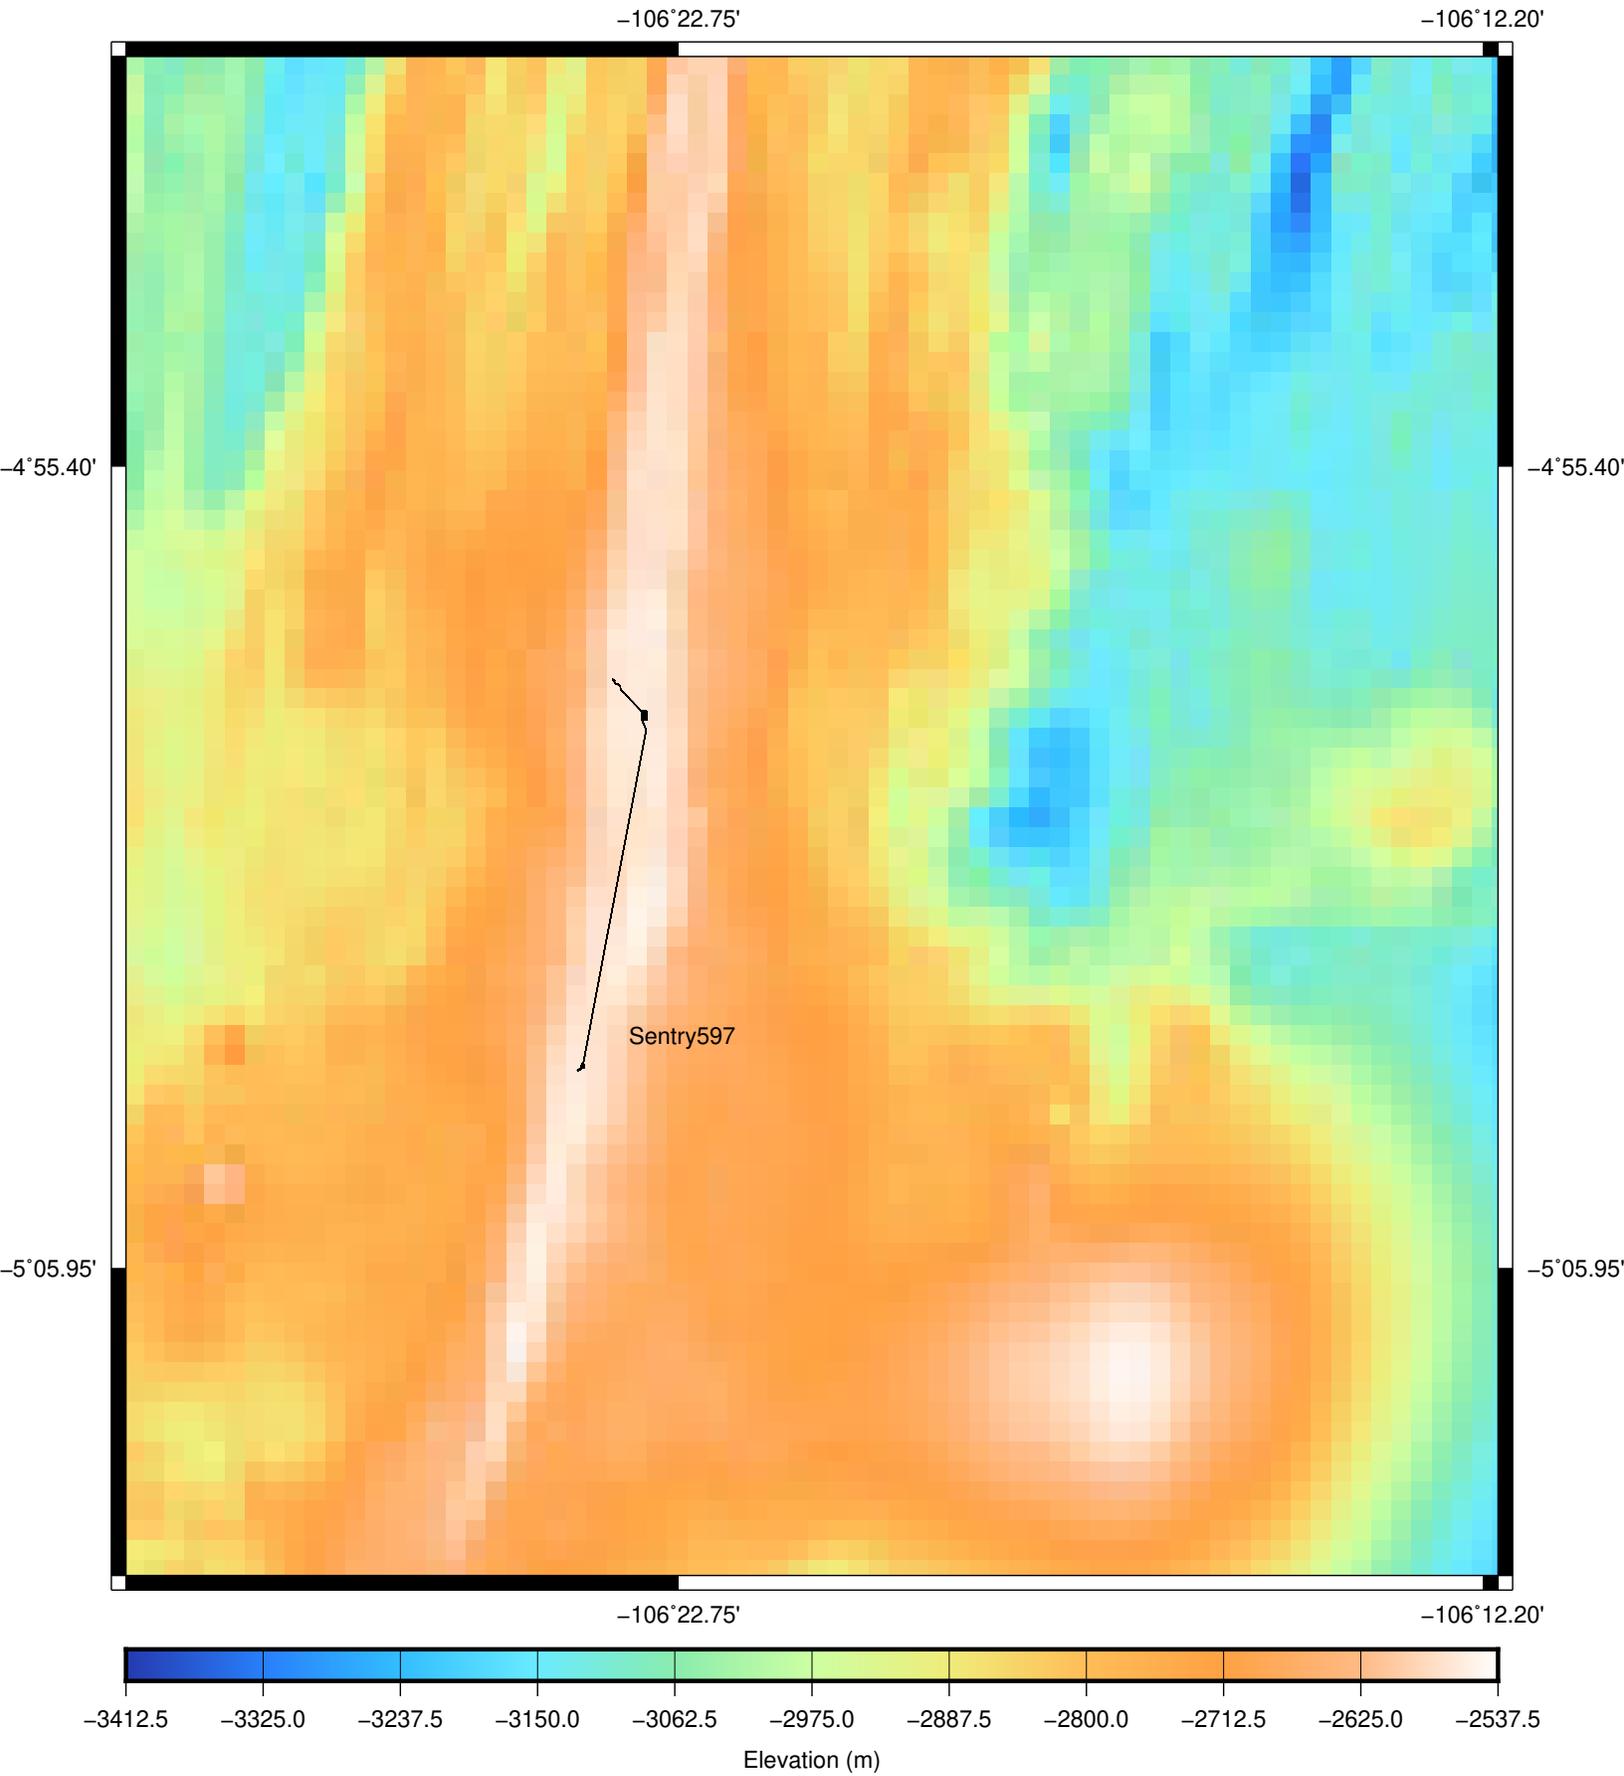
Sentry597 at GOFAR fracture zone

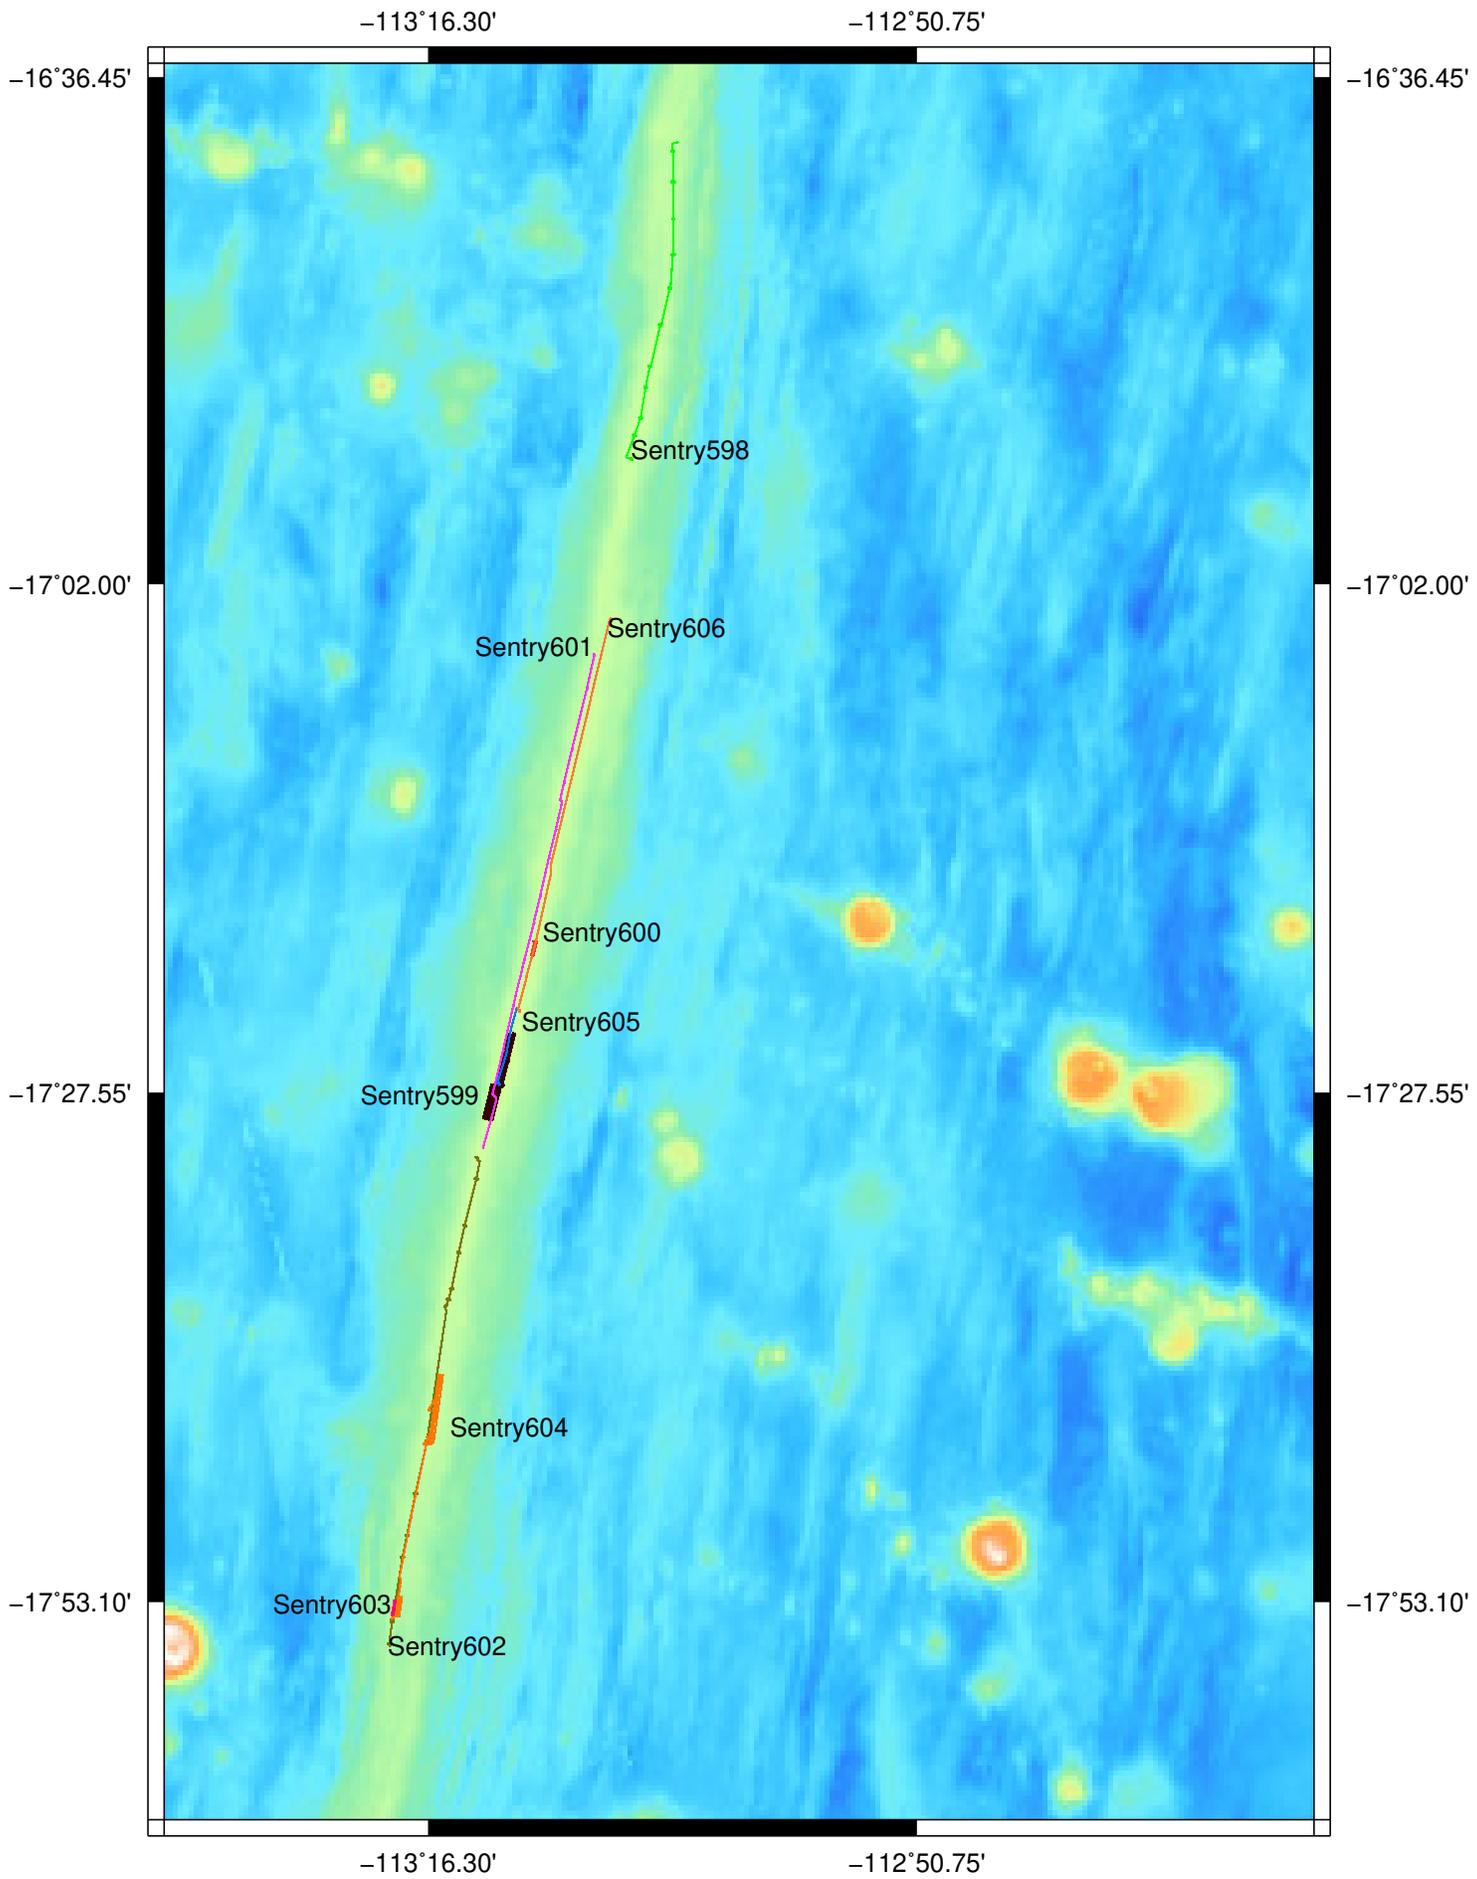
2021 Resing cruise map

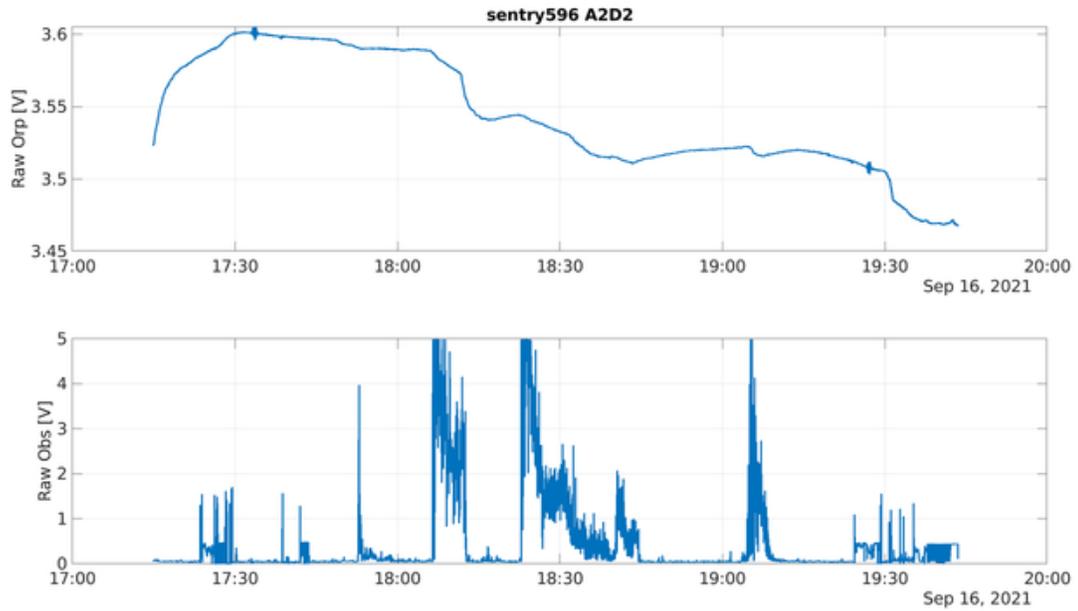
Figure 1: Raw analog Sensor Data

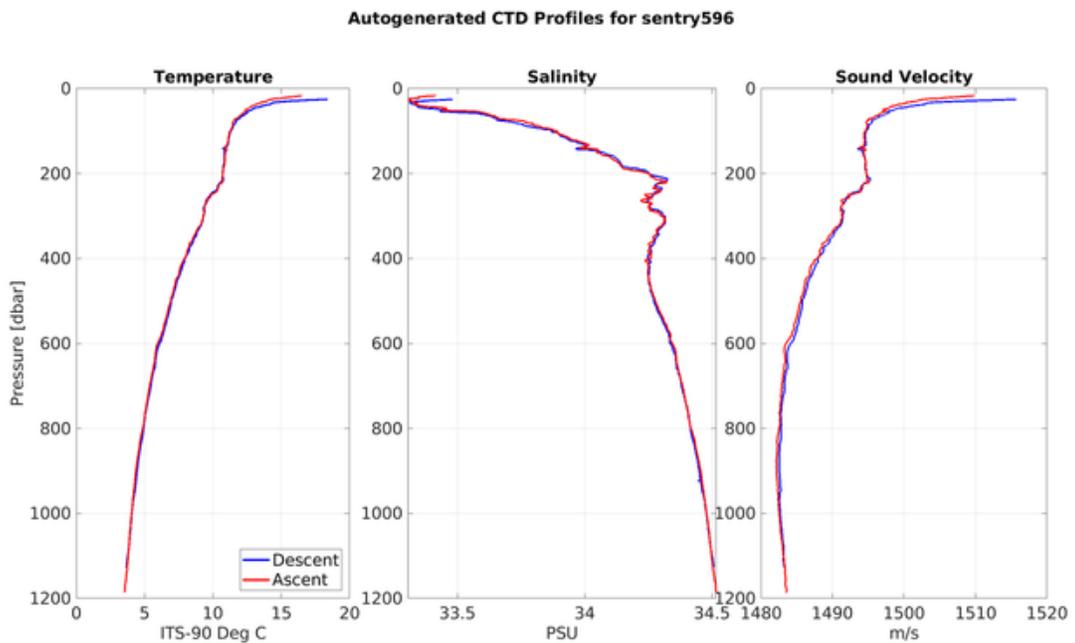
Figure 2: CTD profile sensor data

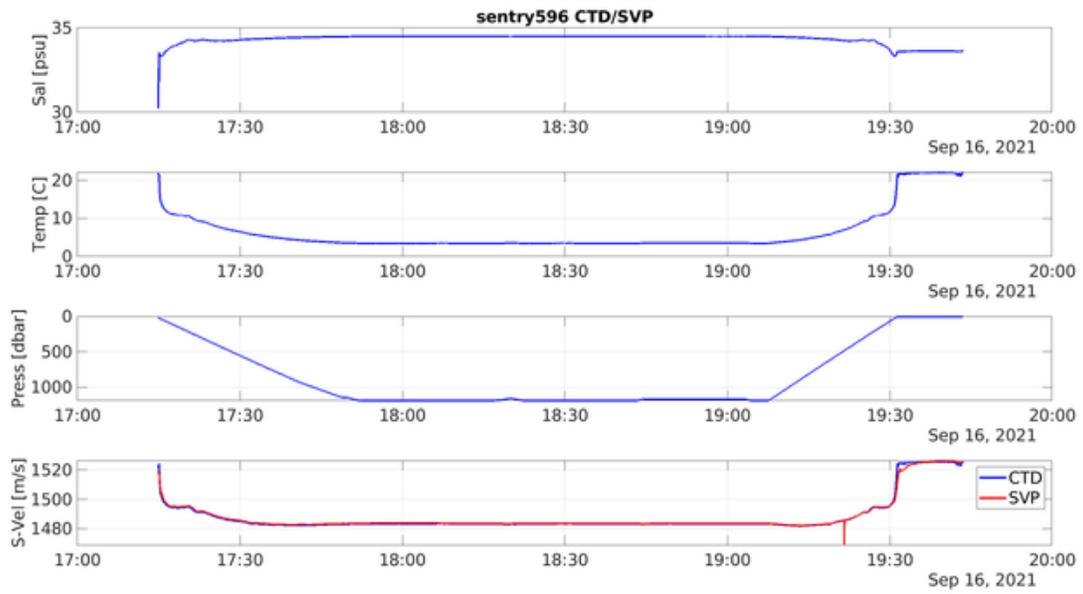
Figure 3: CTD and SVP sensor data

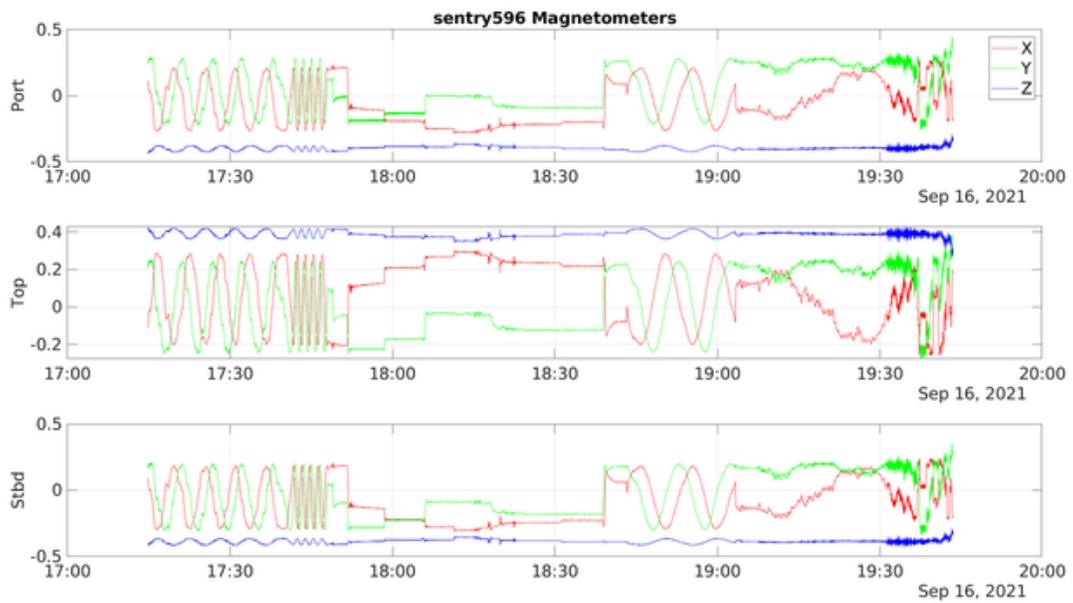
Figure 4: Magnetometer data from each of the three magnetometers on Sentry

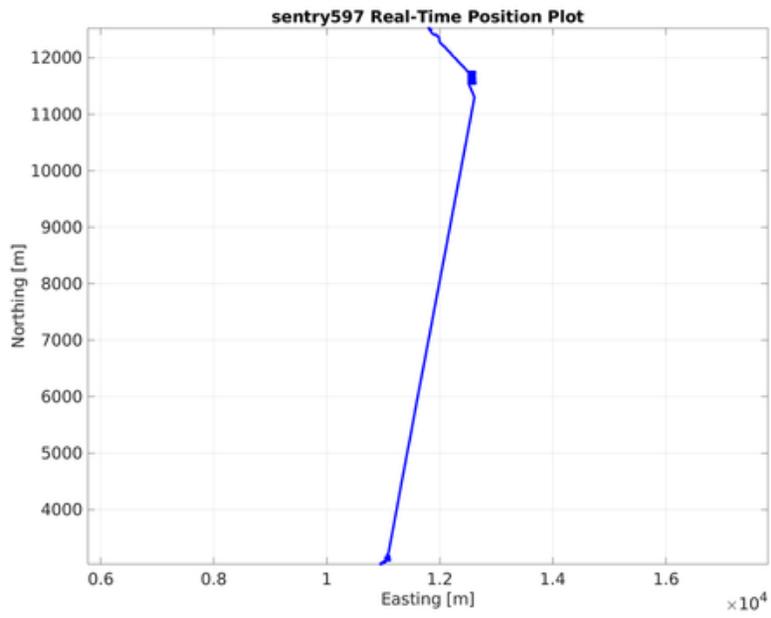
Figure 5: Latitude/Longitude plot of Sentry dive 597 based on post-processed navigation

Sentry completed roughly 9km of trackline, running south to north along the ridge axis at the GOFAR fracture zone. The beginning of the dive started with the descent processing kicking out of the process before reaching the bottom. This required intervention and commanding Sentry to drive to the bottom from roughly 500m altitude. Once on bottom, Sentry started the mission and ran until the programmed end, with a camera box for a holding station at the end of the mission. The survey line and track proved difficult for the CTD to follow along, requiring the vessel to transit at 1.5 knots towing the CTD, a speed that proved to be too much for the CTD wire. Following the recovery of the CTD, Sentry was recovered soon after.

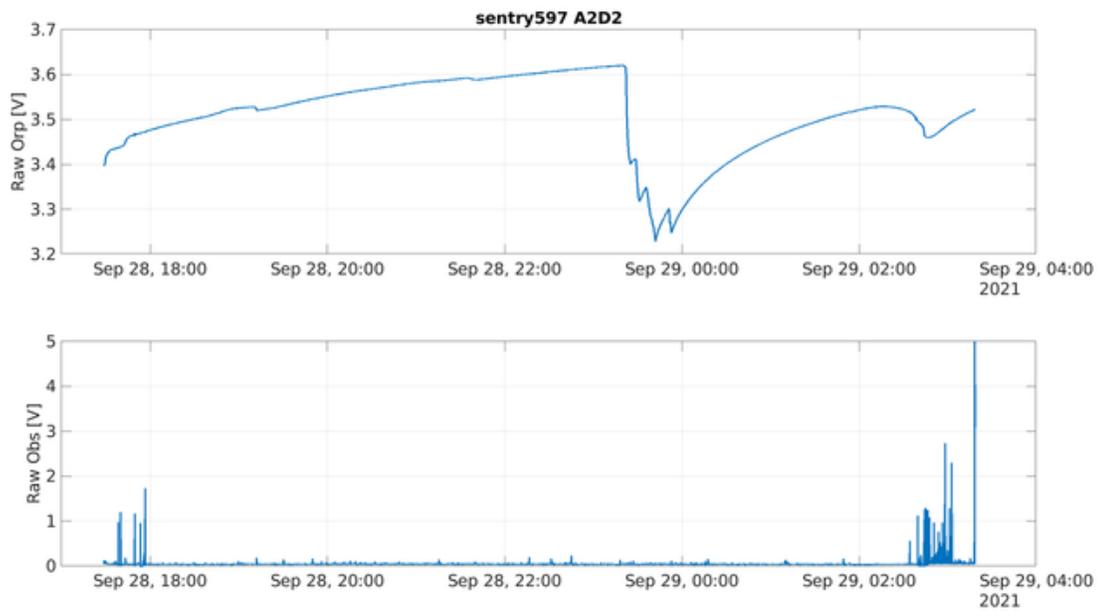
Figure 6: Raw analog Sensor Data

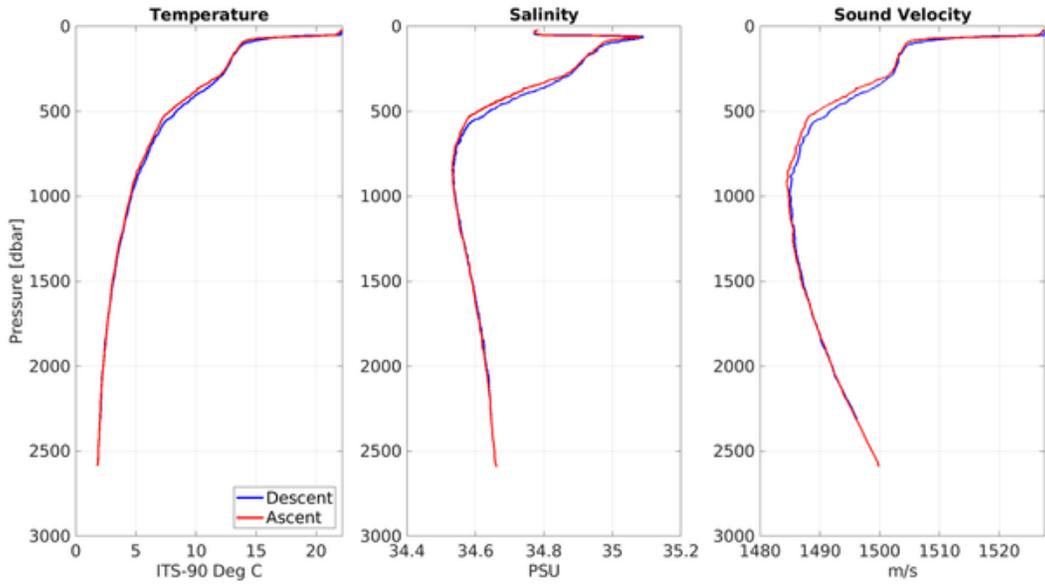
Figure 7: CTD profile sensor data

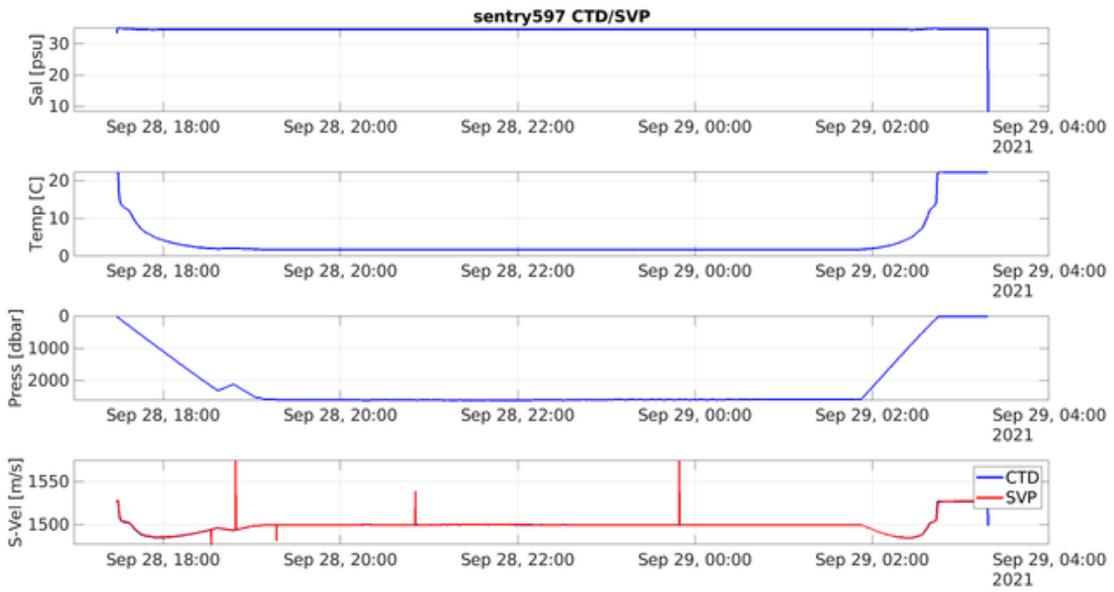
Figure 8: CTD and SVP sensor data

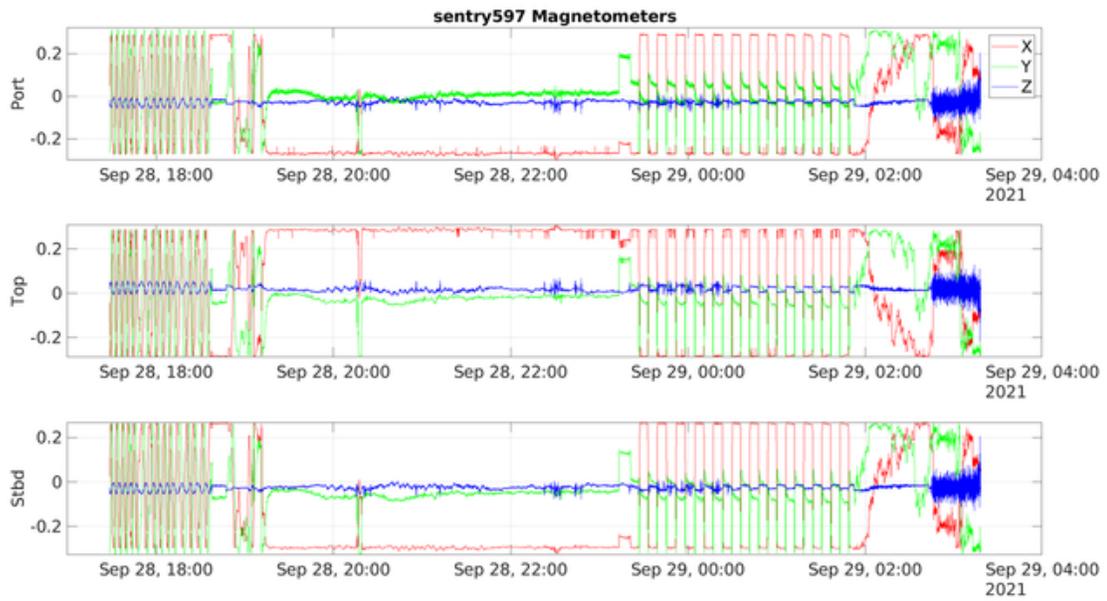
Figure 9: Magnetometer data from each of the three magnetometers on Sentry

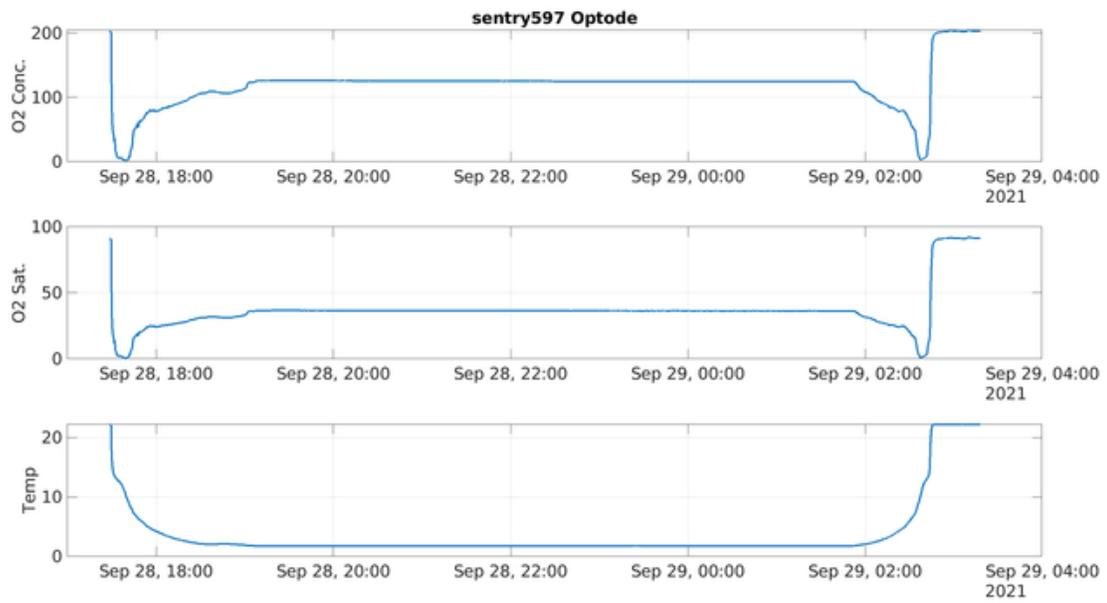
Figure 10: Optode temperature, O2 saturation, and concentration

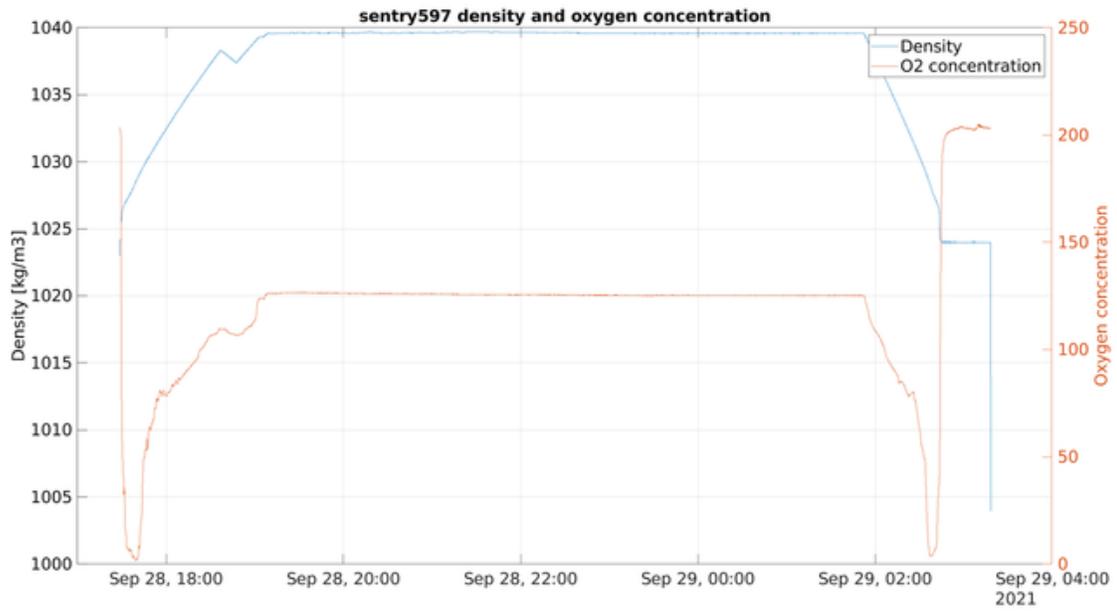
Figure 14: Density and O2 sensor data.

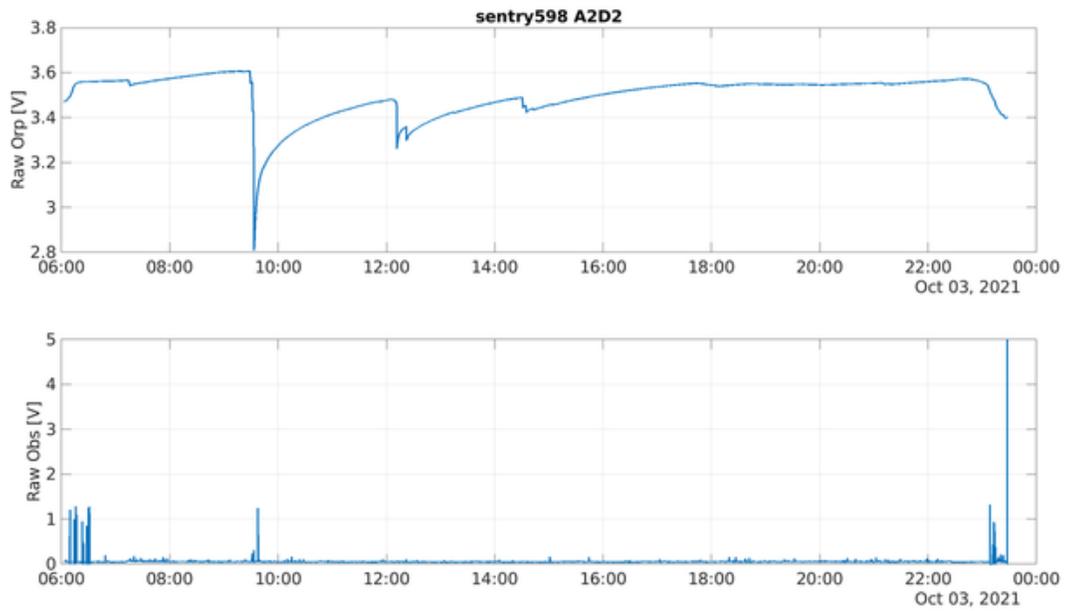
Figure 16: Raw analog Sensor Data

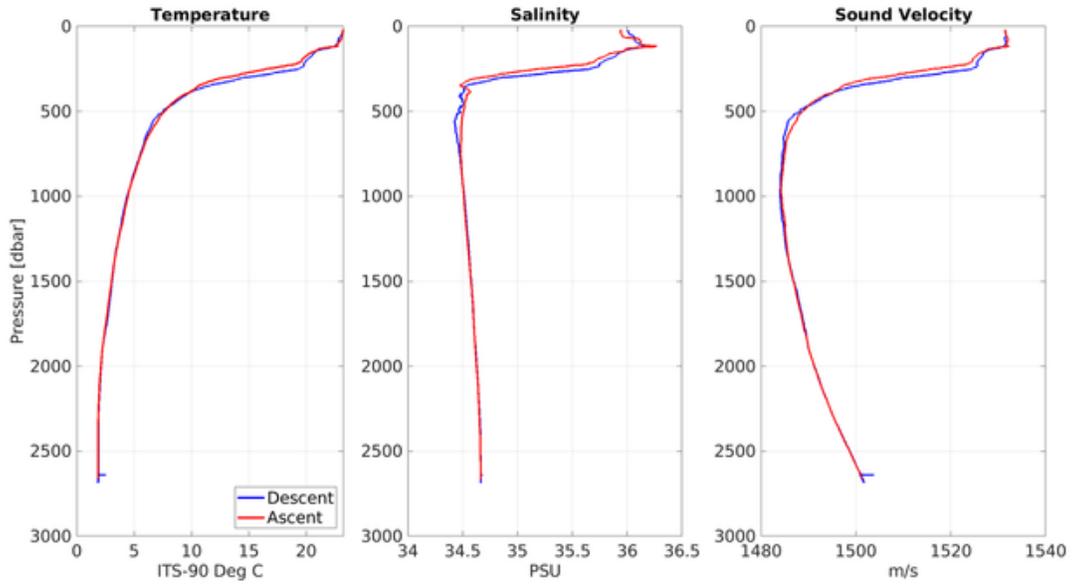
Figure 17: CTD profile sensor data

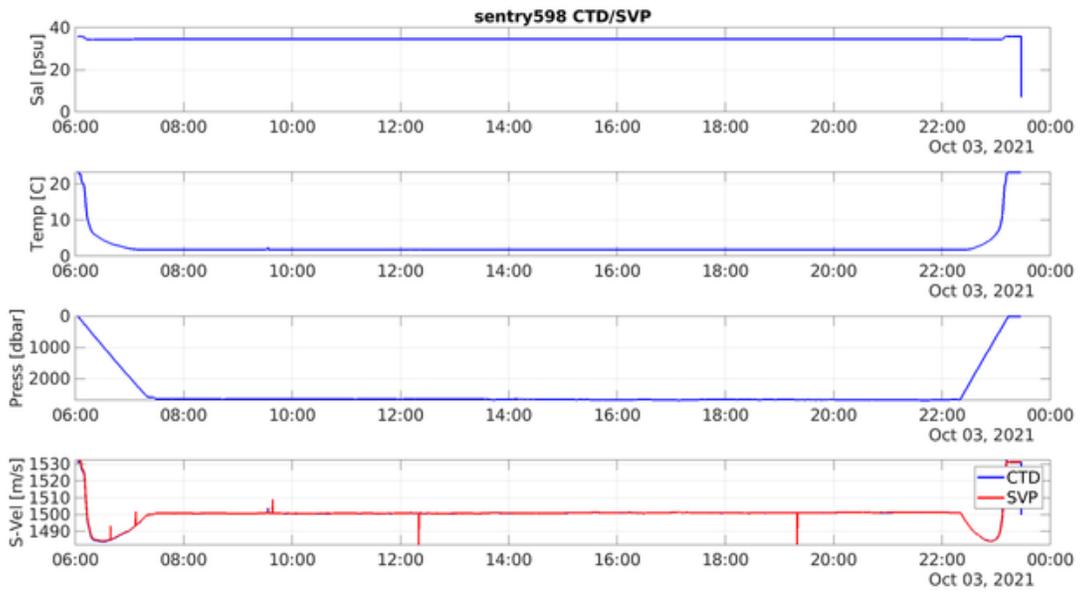
Figure 18: CTD and SVP sensor data

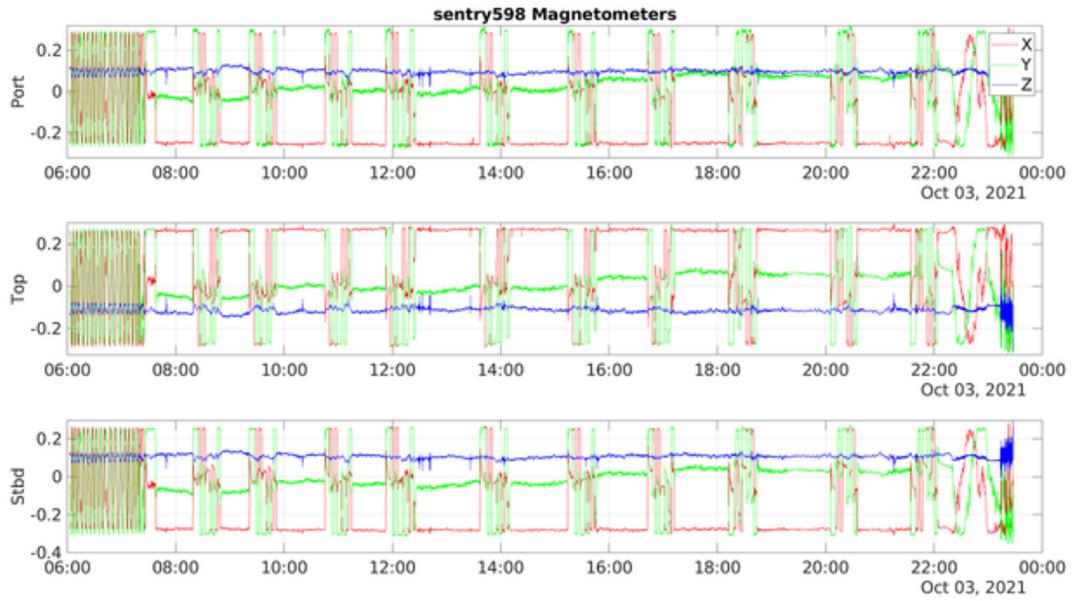
Figure 19: Magnetometer data from each of the three magnetometers on Sentry

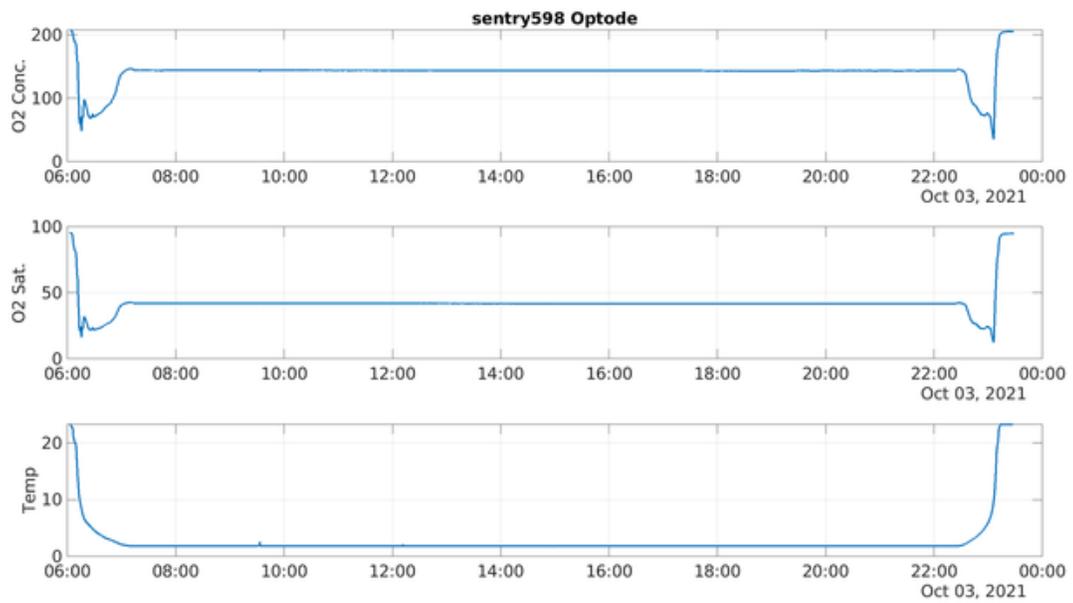
Figure 20: Optode temperature, O2 saturation, and concentration

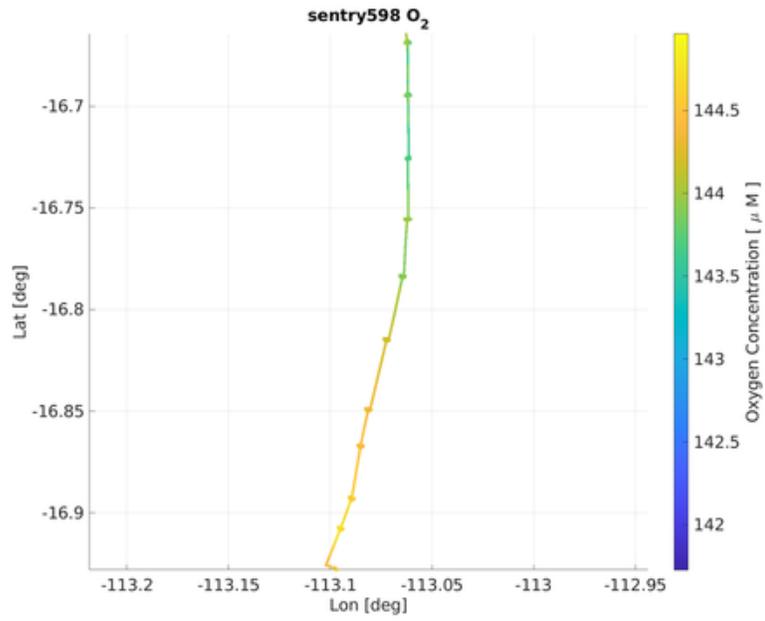
Figure 23: Navigated optode sensor data.

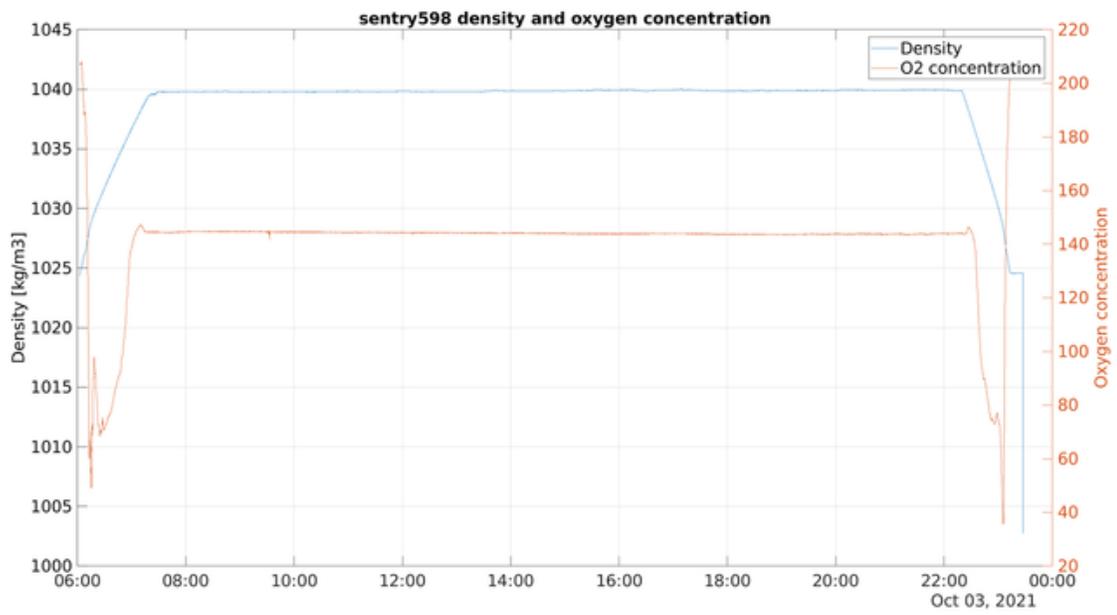
Figure 24: Density and O2 sensor data.
