SENTRY OPERATIONS REPORT FOR THE
CHADWICK/NEMO 2015 CRUISE
DRAFT

WHOI Sentry Operations Group

RV Thomas G. Thompson — August 9, 2015 to August 29, 2015

Sentry 336 Dive Report
DRAFT

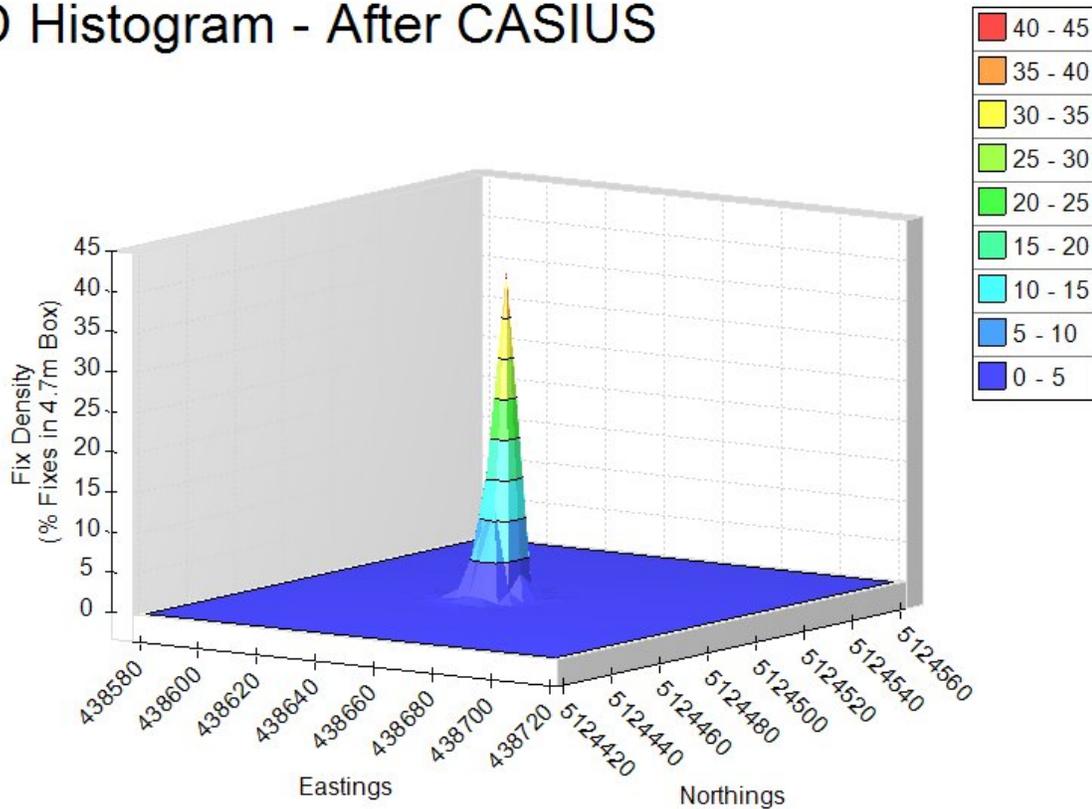
3D Histogram - After CASIUS
