SENTRY OPERATIONS REPORT FOR THE
TN-365 DICK CRUISE
DRAFT

WHOI Sentry Operations Group

R/V Thomas G. Thompson — February 21st through March 28th

Publication Date: March 22, 2019

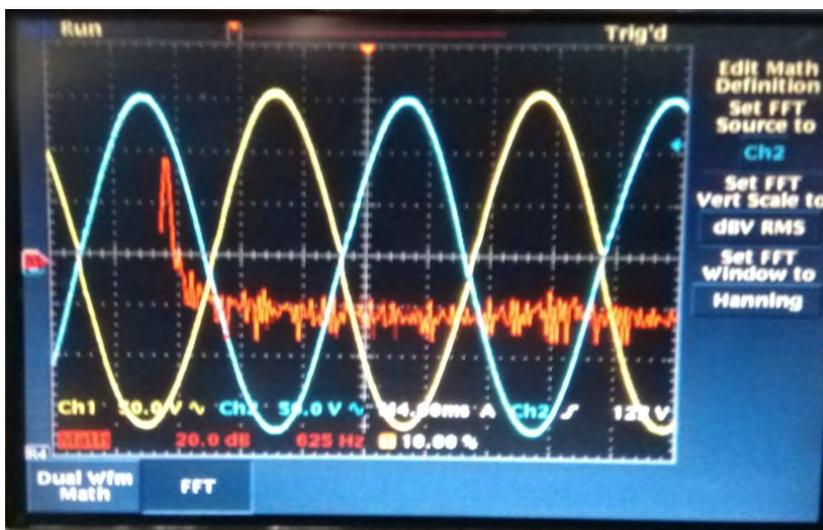
Power Source: Sentry UPS on battery.

Fig5: Container UPS power output on battery, NO connection to vessel power.
