R/V Marcus G. Langseth cruise MGL0706
Cruise Report
John Diebold

Summary

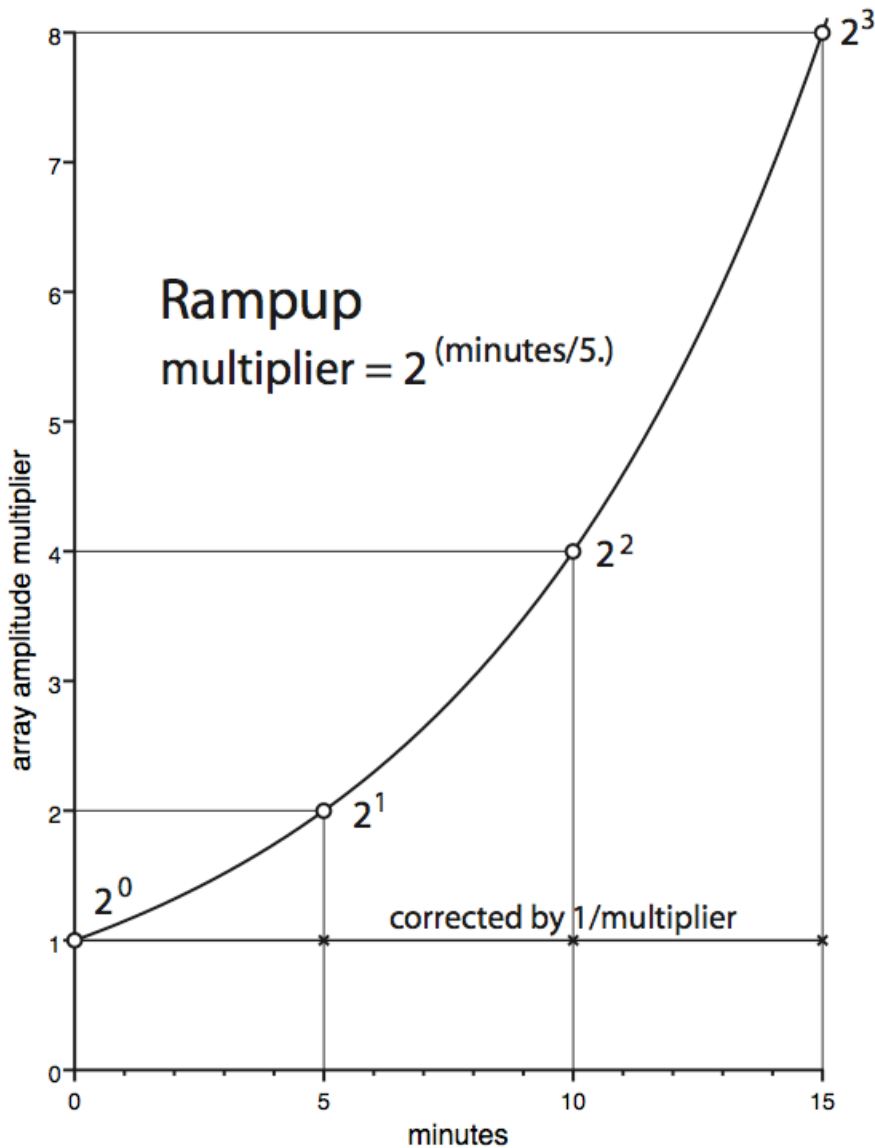
The DigiShot source controller, for all its weaknesses, has a useful automatic rampup sequence. The user specifies the type, and the extent in time or number of “sequences.” The program offers about six different rampups, but in fact there are only two – US style and British [JNCC] style. In order to evaluate them and to demonstrate to our lead MMO that the one I chose to use was correct, I devised a graphical method. The sum of the cube roots of total airguns firing at any time are plotted against time. By applying a correction based on the NMFS criterion of 6 dB per five minutes elapsed time, a flattened, “acceptable” threshold can be plotted:

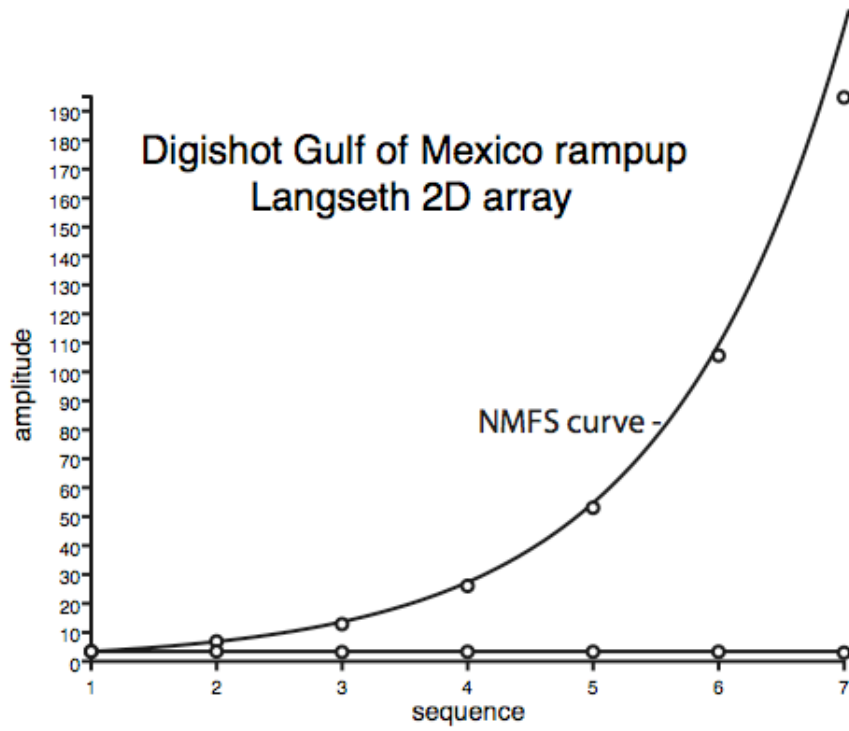
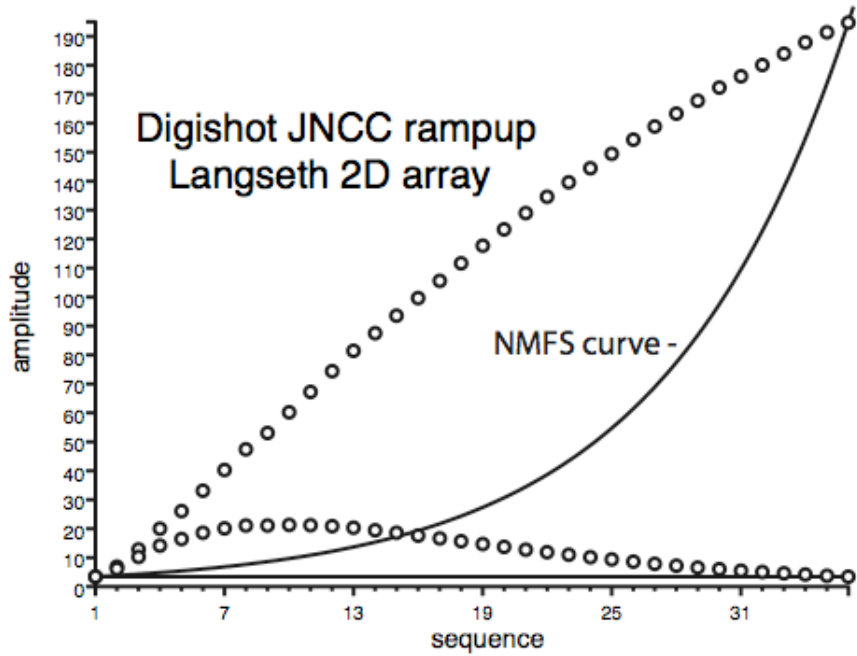
I created tables of the two rampup procedures, as created by DigiShot for the Langseth 2D array:

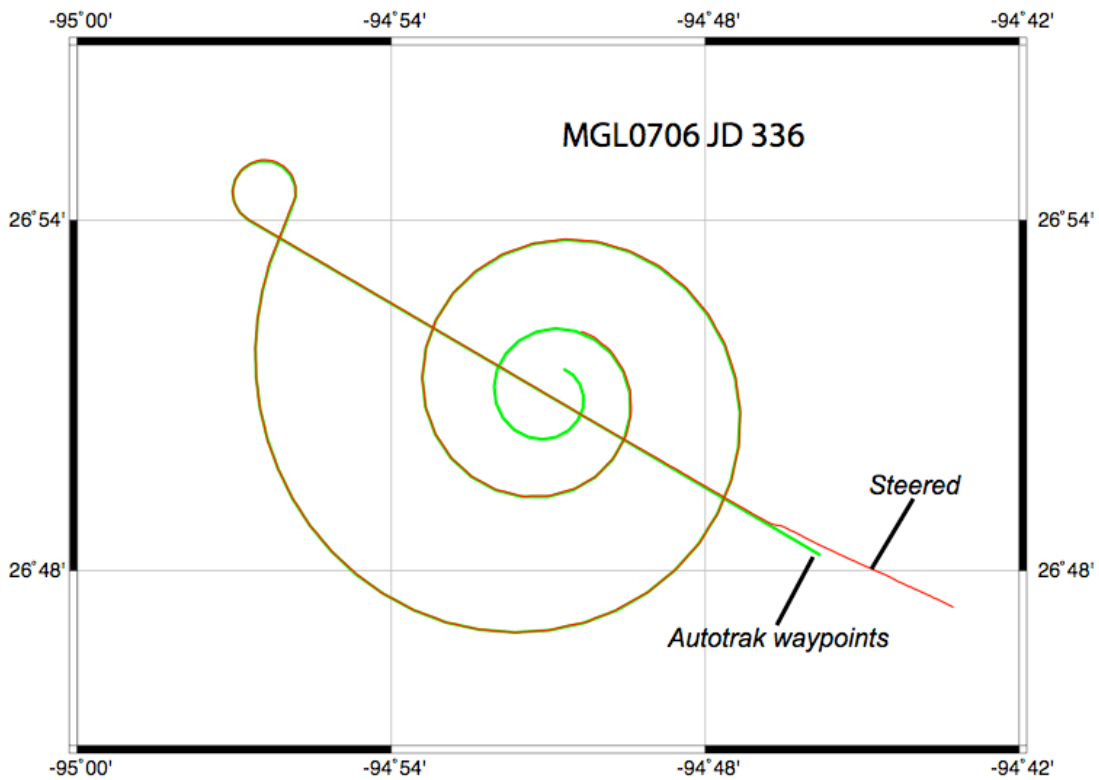
Create a file of x,y waypoints in meters, on an orthogonal grid.
 Use Gmtproject to project these into latitudes and longitudes.
 Reformat the GMT output files to the KDP format [kdp.f]

We succesfully tested the result:

Two methods for transferring waypoints to the Kongsberg DP system were tried. The first, based on a brief successful experiment by Anthony Johnson, involved transmission of NMEA strings via a serial connection:

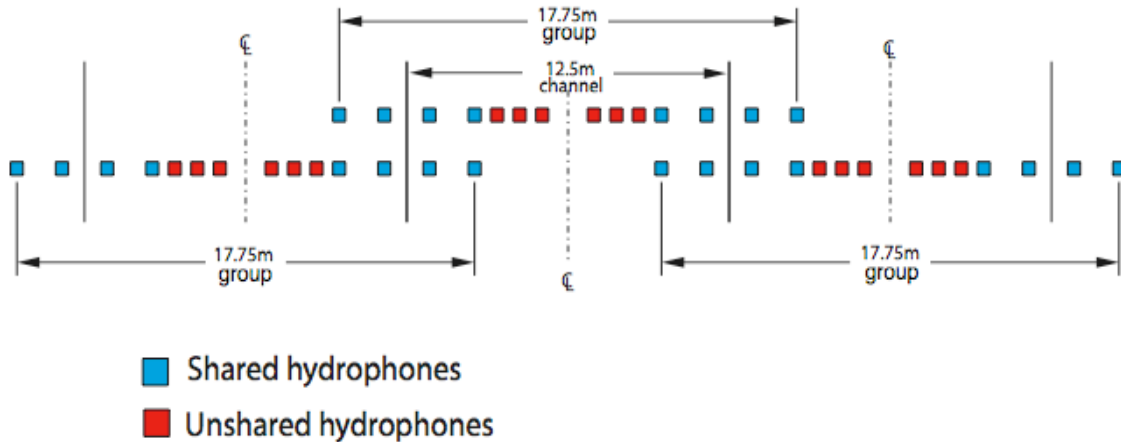
Hydrophone layout - R/V Langseth MCS streamers

Appendix: Syntak MCS streamer hydrophone layout

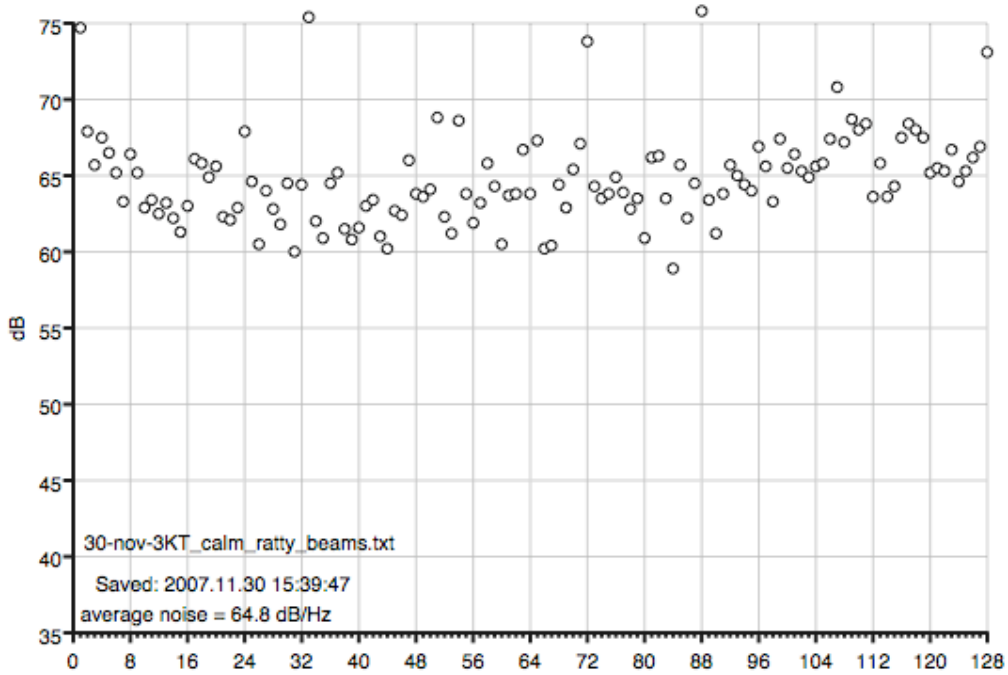
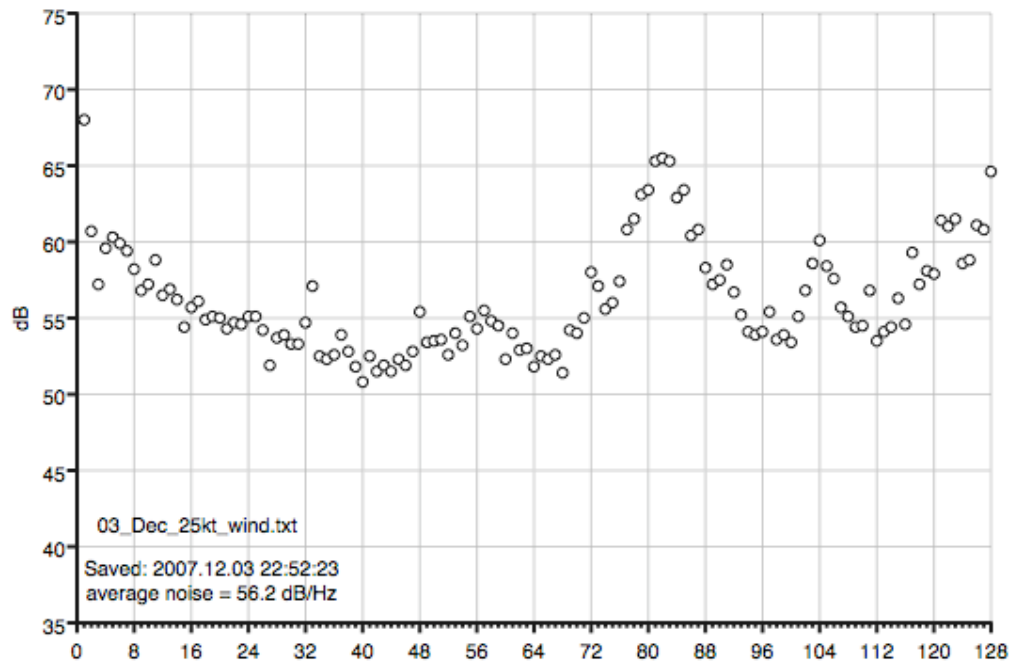
The multibeam was kept running for the entire cruise, and data were logged, though little effort was made to conduct systematic survey data. Data quality varied a lot, often, seemingly, dependent on weather and sea state. During the course of the leg several self-noise tests were run, and some of those tests seem to contradict this apparent dependence. No further investigation into causal relationships between ships machinery and self-noise were carried out.
