MGL0801

3 - 24 January 2008

cruise report
draft 27 Jan. 2008

ML0801
Galveston – Galveston 3 – 24 January 2008

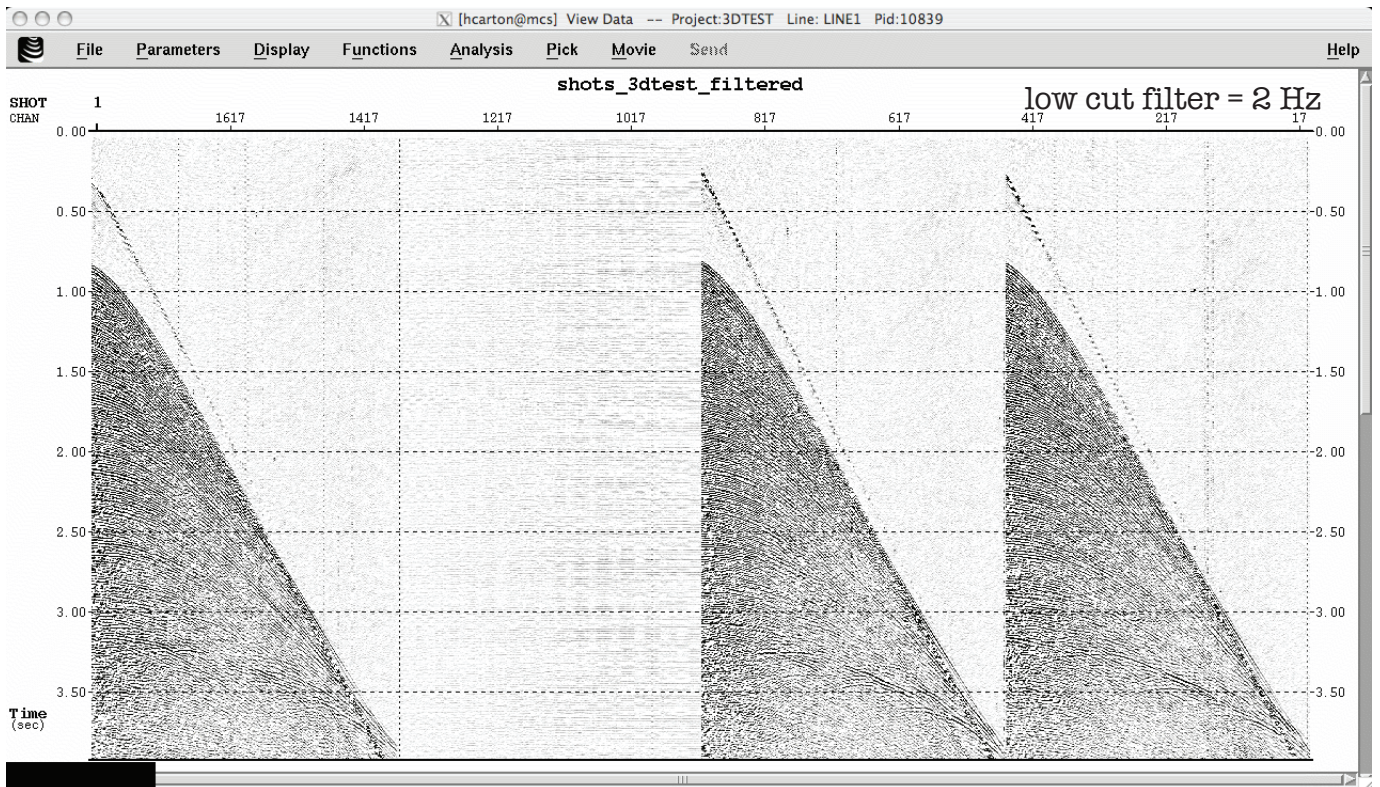
MGL0801 3D test line shot gathers

cable 1

cable 3

cable 4

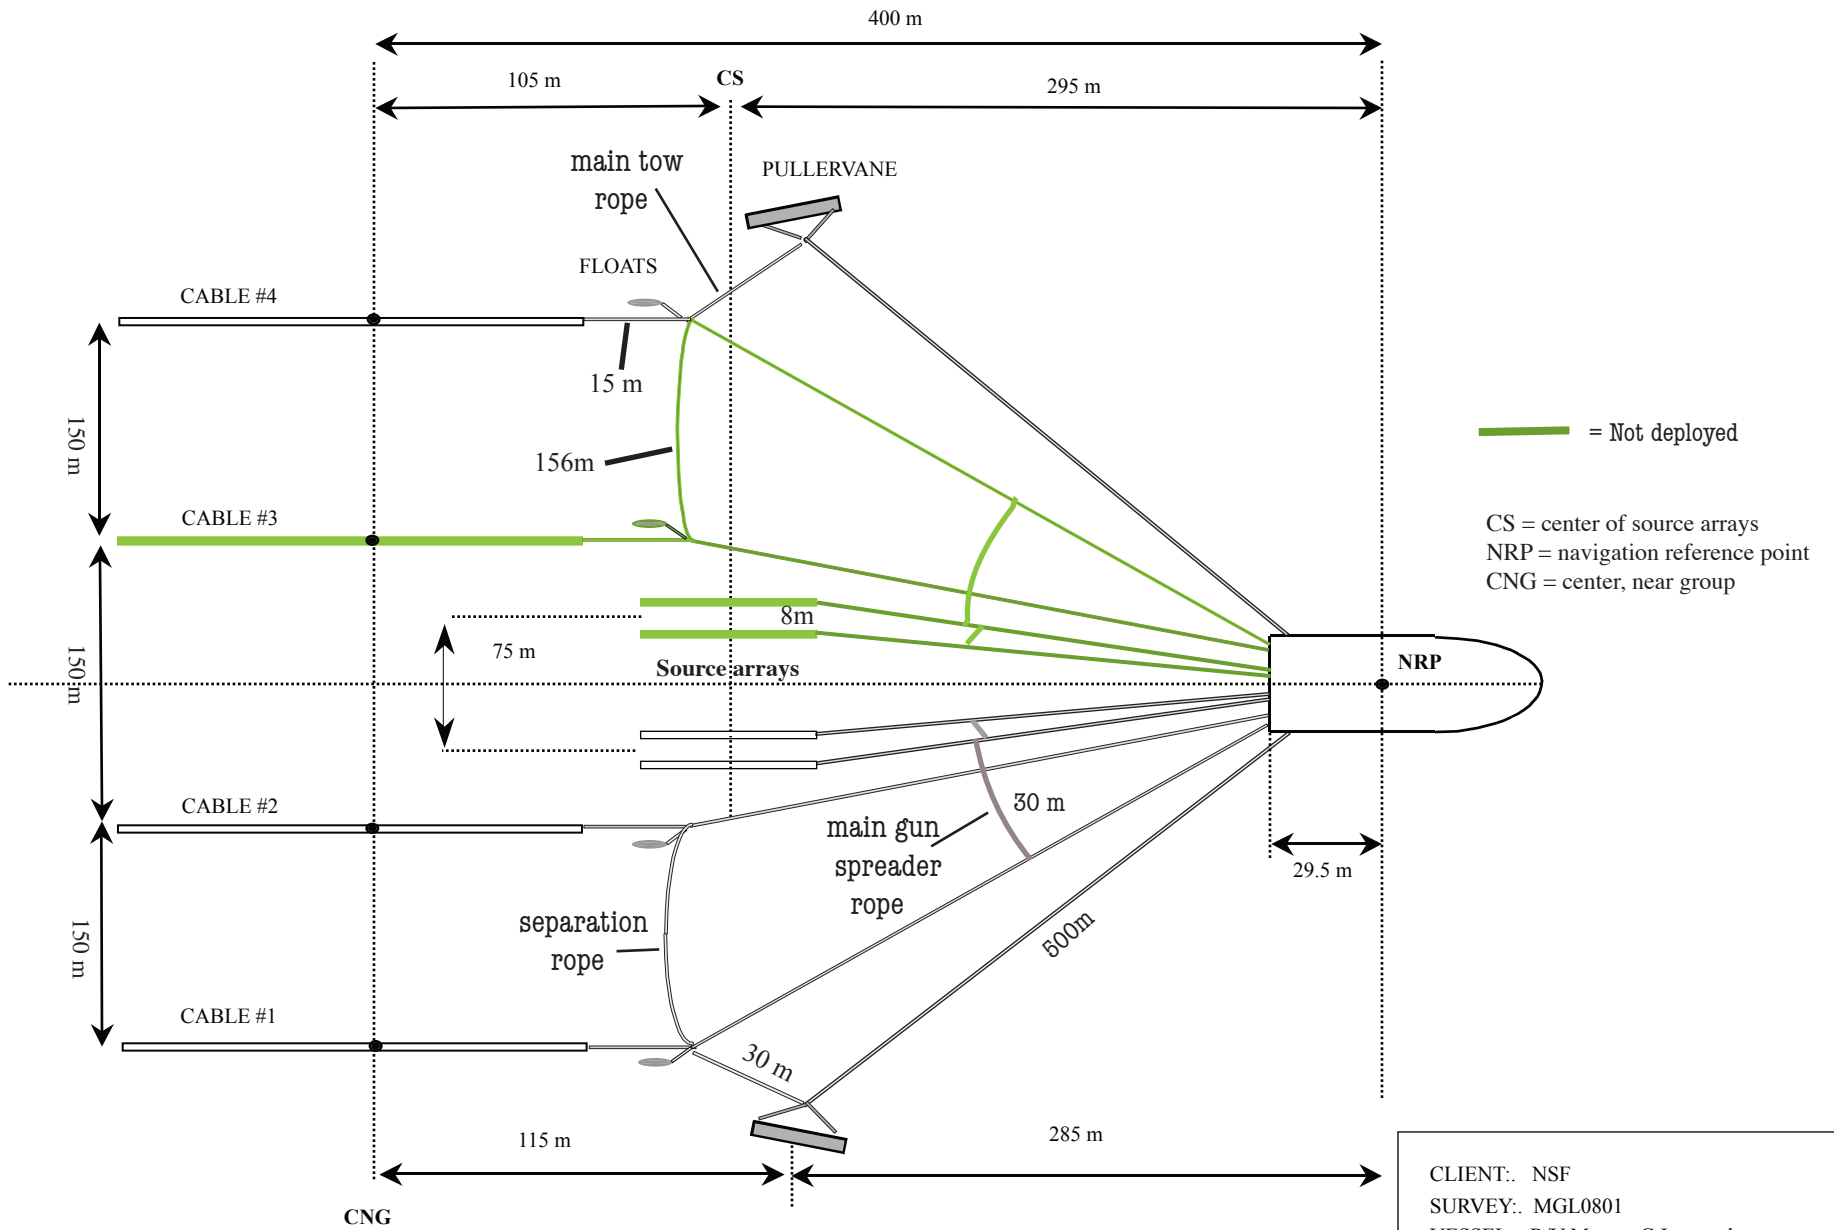
TOWING CONFIGURATION AND OFFSETS

Note: Drawing not to scale

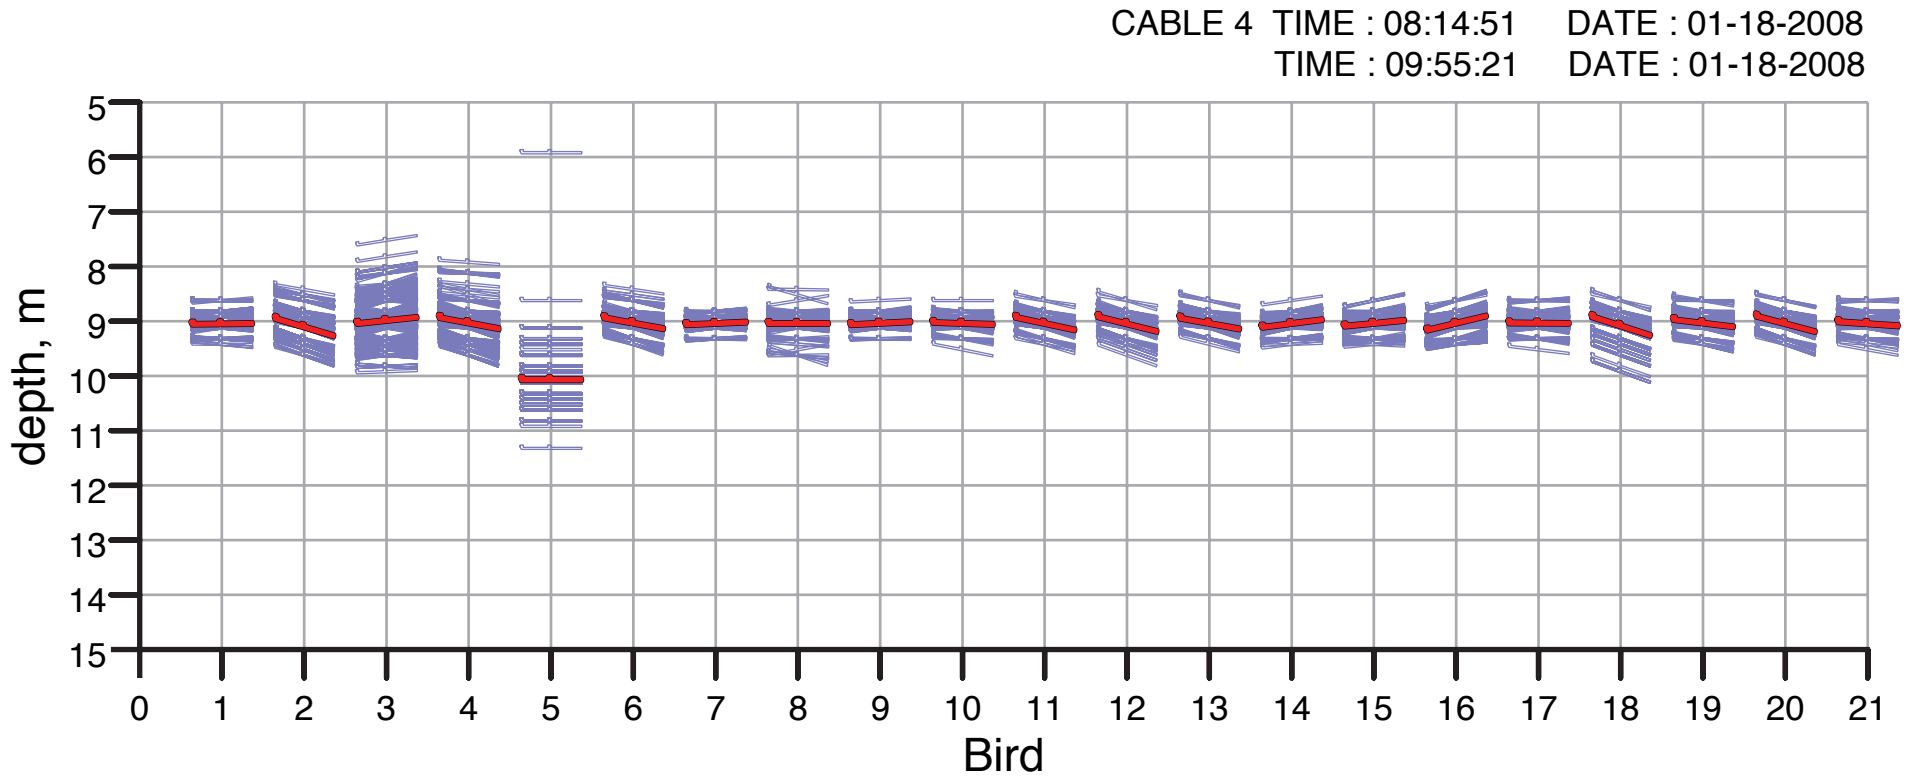
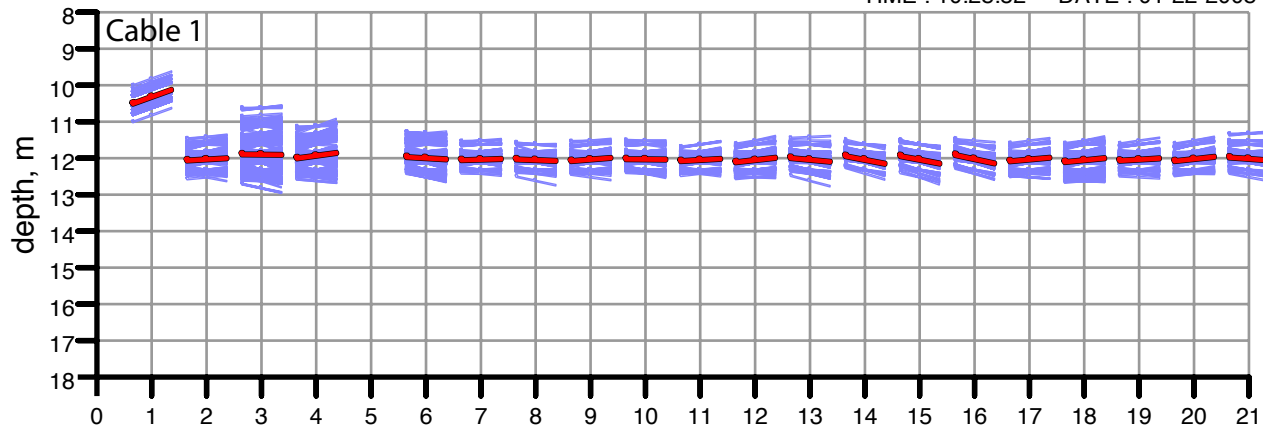
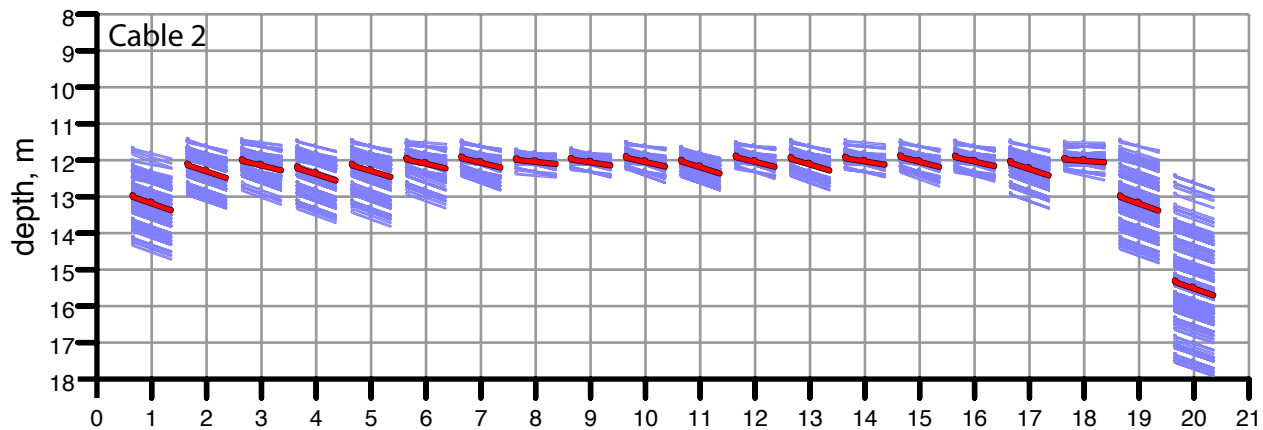
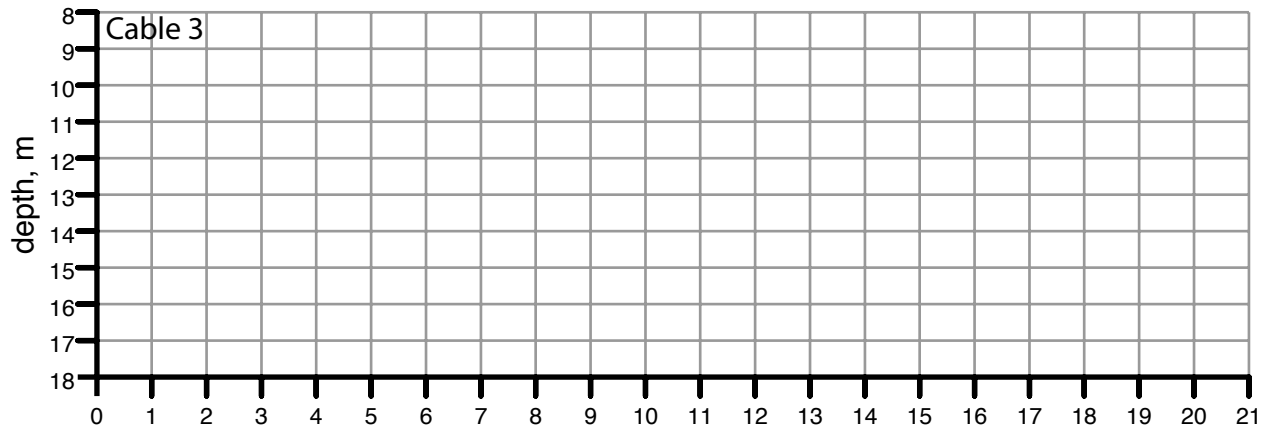
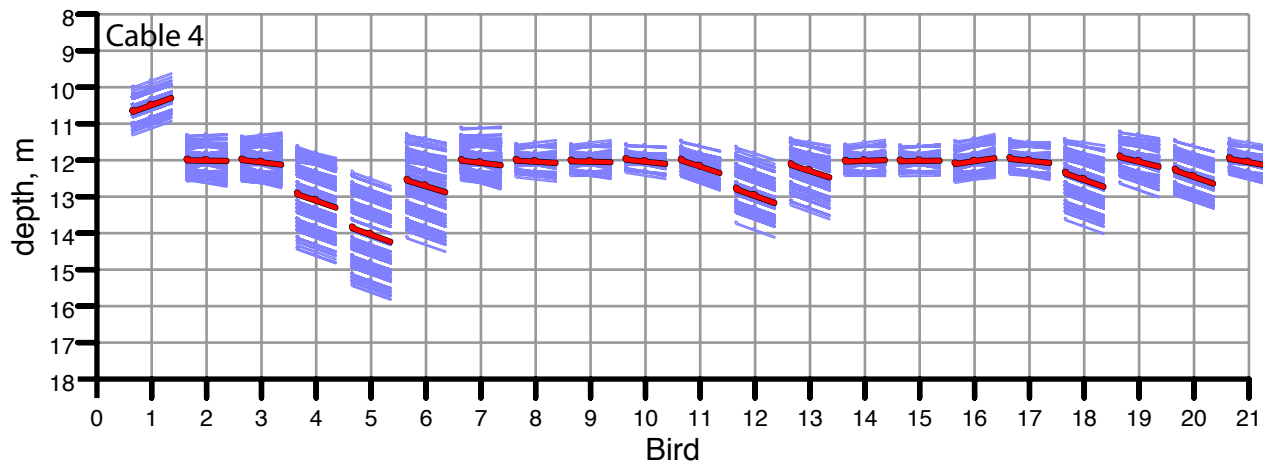
Bird fin angle/depth plots:

The Digicourse bird controller will log fin angle, depth and temperature if desired. The resulting log files are useful for assessing ballasting and overall depth control. This example is a plotted summary for a single cable over the course of an hour and forty minutes. Individual entries are plotted in light blue, overall bird-by-bird averages in red.

TIME : 09:29:02 DATE : 01-22-2008
TIME : 10:28:52 DATE : 01-22-2008

Streamer 1
